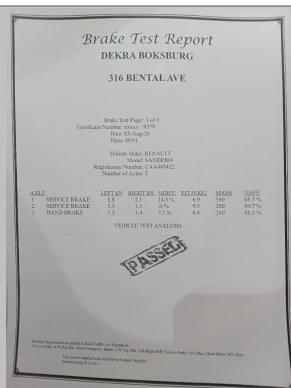
Brake test report

| | Left | Right | | |
|---|---|---|---|---|
| Front | 1.8 | 2.1 | - | |
| Rear | 1.3 | 1.3 | - | |
| Emergency / Parking | 1.3 | 1.4 | - | |

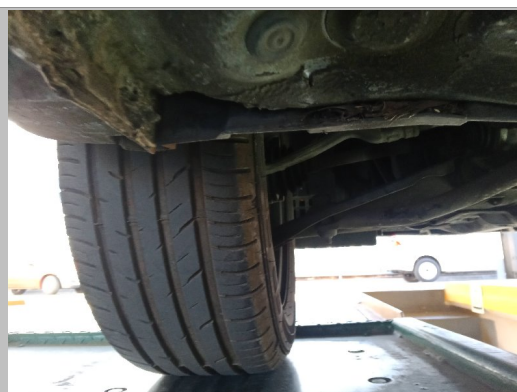
LF TYRE TREAD

| | Size | Load/Speed Index | Manufacture | Model | Type* | Production Date | Tread Depth (mm) |
|---|---|---|---|---|---|---|---|
| Front Left | 205/55R16 | 91V | Dunlop | SP Sport | V | 2425 | 4 mm |

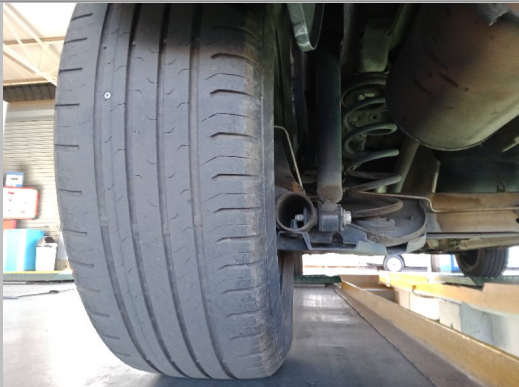
LR TYRE TREAD

| | Size | Load/Speed Index | Manufacture | Model | Type* | Production Date | Tread Depth (mm) |
|---|---|---|---|---|---|---|---|
| Rear Left | 205/55R16 | 91H | Continental | Contact 5 | V | 0619 | 3 mm |

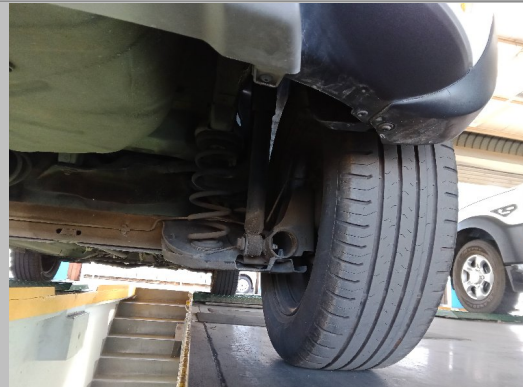
RR TYRE TREAD

| | Size | Load/Speed Index | Manufacture | Model | Type* | Production Date | Tread Depth (mm) |
|---|---|---|---|---|---|---|---|
| Rear Right | 205/55R16 | 91H | Continental | Contact 5 | V | 0619 | 3 mm |

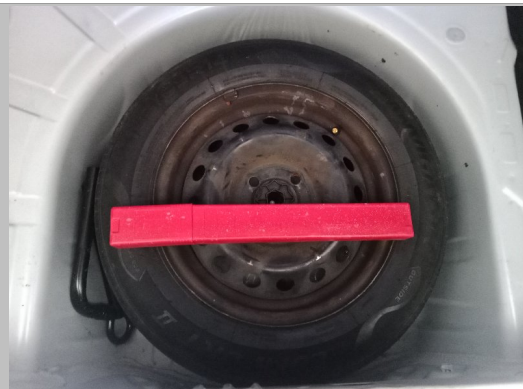
Sparewheel

| | Size | Load/Speed Index | Manufacture | Model | Type* | Production Date | Tread Depth (mm) |
|---|---|---|---|---|---|---|---|
| Spare | 185/65R14 | 86H | Lanvigator | Comfort | V | 2221 | 0 mm |

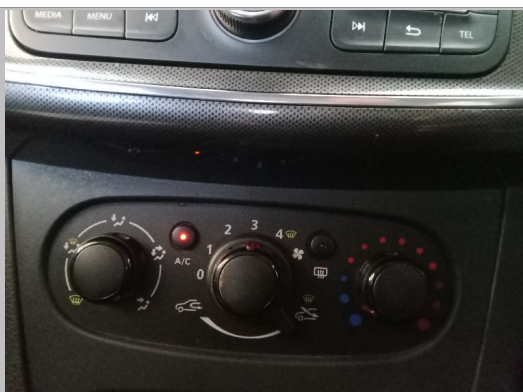
Aircon working
