Private Client

DEKRA Boksburg
Bentel Ave - 1459
BOKSBURG - GT
011 826 4386

Vehicle Type	PASSENGER VEHICLE	Registered Owner	CBK MOTORS CBK MOTORS
Manufacturer	VOLKSWAGEN	Registration Number	LB02KGGP
Model	POLO 1.0 TSI 70KW COMFORTLINE 5-DR [2020-2022]	Register Number	HYG360K
VIN	AAVZZAWZMU025955	Date Of First Licensing	
Engine Number	CHZD55535	Last COR	
Doors	5	License Expiry Date	
Color	GREY	Power / Displacement	70Kw. 999Ccm
Year Model	2020	Paint Finish	M - METALLIC
Km Reading	111,499 KM	Fuel	PETROL
Cab / Body Type	HATCHBACK	Transmission	MANUAL

VEHICLE INSPECTION

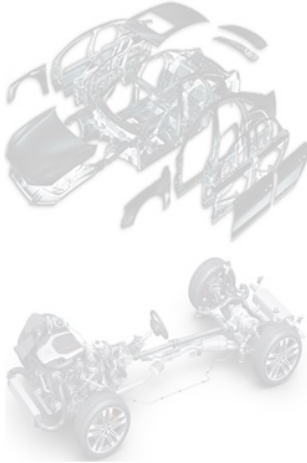
Damage

General Comments: ACCORDING TO AGE AND MILEAGE OF VEHICLE NORMAL WEAR AND TEAR ON INTERIOR, EXTERIOR, ELECTRICAL AND MECHANICAL PARTS. Body • Exterior: Minor dents scratches and stone chips
Undercarriage: Under carriage mostly covered

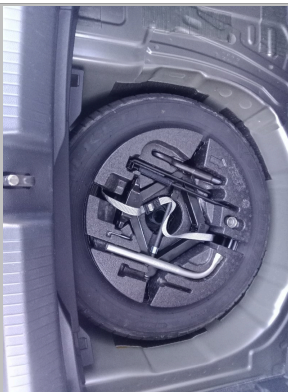
Spare tyre

Size	Load/Speed Index	Manufacture	Model	Type*	Production Date	Tread Depth (mm)
Front Left	215/45R17	91Y	Apollo	Aspire	V	3223	4 mm
Front Right	215/45R17	91Y	Apollo	Aspire	V	3223	4 mm
Rear Left	215/45R17	91W	Continental	Contact 5	V	0721	4 mm
Rear Right	215/45R17	91W	Continental	Contact 5	V	2621	4 mm
Spare	185/65R15	86/H	Falken	Sincere	V	0000	5 mm

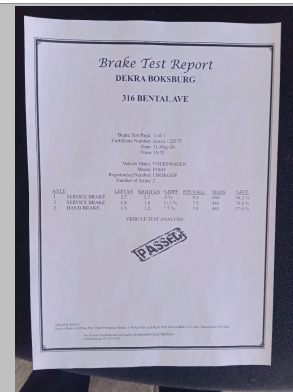
Brake report

Left	Right		
	Braking Force [KN]	Braking Force [KN]	Axle Weight [KG]	Deceleration [m/s ²]
Front	2.7	2.7	-	
Rear	1.8	1.6	-	
Emergency / Parking	1.3	1.2	-
