DEKRA Boksburg  
Bentel Ave - 1459  
BOKSBURG - GT  
011 826 4386

| Manufacturer | GWM | Registration Number | DJ52RVZN |
| Model | STEED 2.0 SX D-CAB DSL PU [2022-2024] | Register Number | JLV936L |
| VIN | LGWCBE171NB667579 | Date Of First Licensing | |

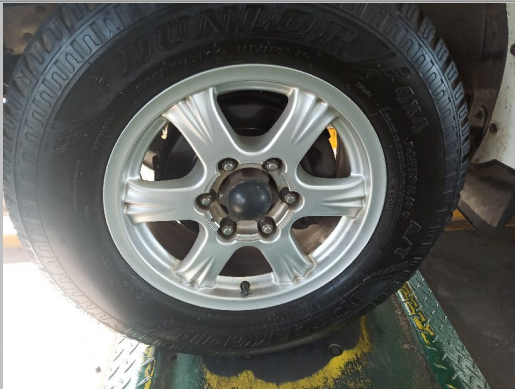
General Comments: ACCORDING TO THE AGE AND MILEAGE OF THE VEHICLE, NORMAL WEAR AND TEAR MARKS ON BODY, INTERIOR AND MECHANICAL PARTS. Body • Exterior: Minor dents, scratches and stone chips on some body panels  
Tyres and Rims: LEFT FRONT TYRE CENTER CAP MISSING

L/F TYRE CENTER CAP

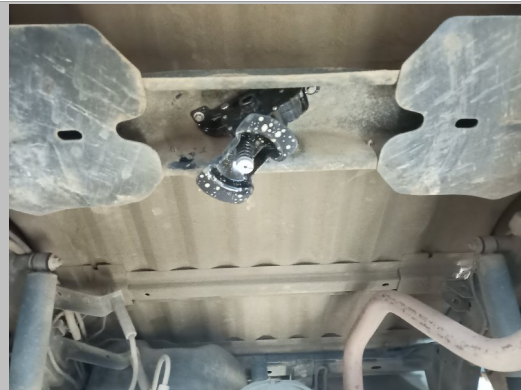
NO SPAREWHEEL

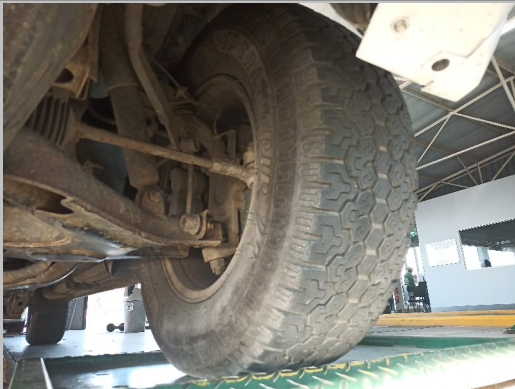
LF TYRE TREAD

| | Size | Load/Speed Index | Manufacture | Model | Type* | Production Date | Tread Depth (mm) |
|---|---|---|---|---|---|---|---|
| Front Left | 245/70R16C | 111/109S | DUNLOP | 245/70R16C | V | 0724 | 7 mm |

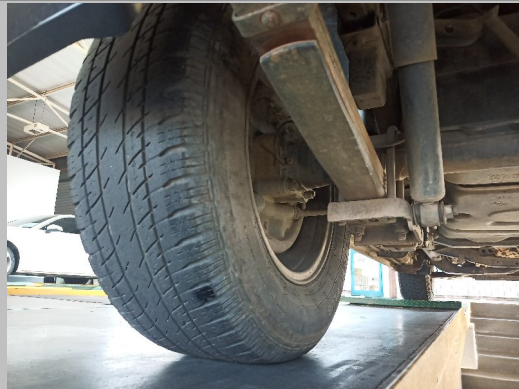
LR TYRE TREAD

| | Size | Load/Speed Index | Manufacture | Model | Type* | Production Date | Tread Depth (mm) |
|---|---|---|---|---|---|---|---|
| Rear Left | 235/70R16 | 106T | GITI | SAVERO HT PL | V | 0722 | 4 mm |

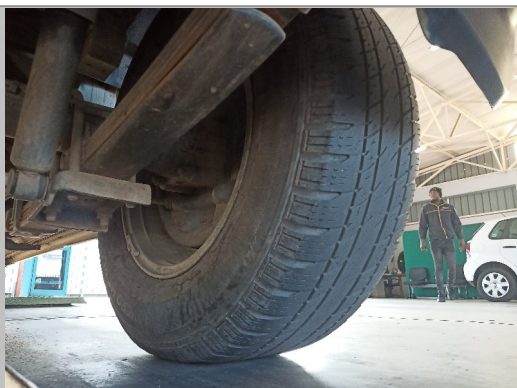
RR TYRE TREAD

| | Size | Load/Speed Index | Manufacture | Model | Type* | Production Date | Tread Depth (mm) |
|---|---|---|---|---|---|---|---|
| Rear Right | 235/70R16 | 106T | GITI | SAVERO HT PL | V | 0722 | 7 mm |

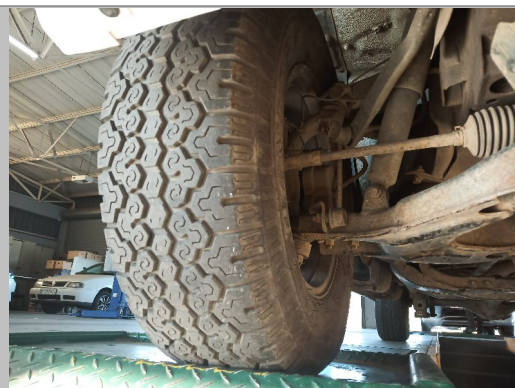
RF TYRE TREAD

| | Size | Load/Speed Index | Manufacture | Model | Type* | Production Date | Tread Depth (mm) |
|---|---|---|---|---|---|---|---|
| Front Right | 245/70R16C | 111/109S | DUNLOP | SP TRAKGRIP | V | 0324 | 6 mm |
