## Assignment

| Manufacturer | VOLKSWAGEN | Registration Number | NU730ZN |
| Model | GOLF 7 1.2 TRENDLINE 77KW 5-DR [2013-2016] | Register Number | GGH420K |

## VEHICLE INSPECTION

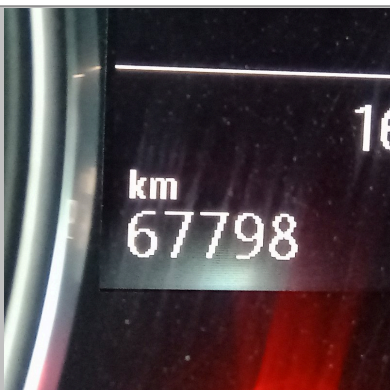
ODOMETER

| Km Reading | 67,798 KM | Fuel | PETROL |

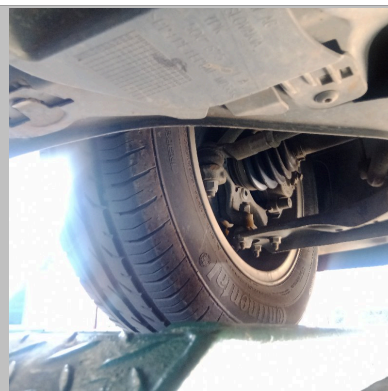
LF TYRE TREAD

| | Size | Load/Speed Index | Manufacture | Model | Type* | Production Date | Tread Depth (mm) |
|---|---|---|---|---|---|---|---|
| Front Left | 195/65R15 | 91H | Continental | Contact 2 | V | 1823 | 6 mm |

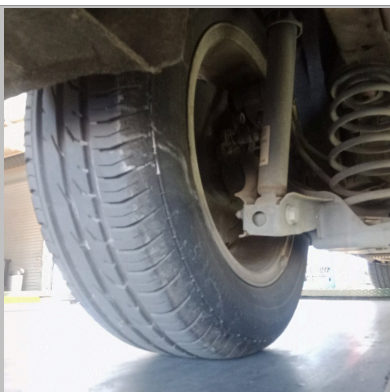
LR TYRE TREAD

| | Size | Load/Speed Index | Manufacture | Model | Type* | Production Date | Tread Depth (mm) |
|---|---|---|---|---|---|---|---|
| Rear Left | 195/65R15 | 91H | Continental | Contact 2 | V | 4922 | 6 mm |

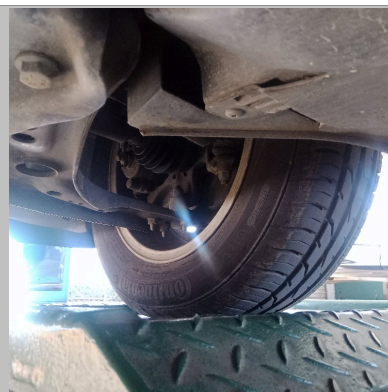
RF TYRE TREAD

| | Size | Load/Speed Index | Manufacture | Model | Type* | Production Date | Tread Depth (mm) |
|---|---|---|---|---|---|---|---|
| Front Right | 195//65R15 | 91H | Continental | Contact 2 | V | 1923 | 6 mm |

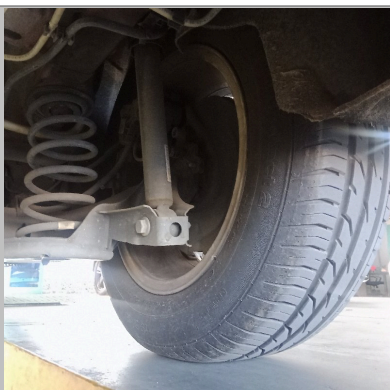
RR TYRE TREAD

| | Size | Load/Speed Index | Manufacture | Model | Type* | Production Date | Tread Depth (mm) |
|---|---|---|---|---|---|---|---|
| Rear Right | 195/65R15 | 91H | Continental | Contact 2 | V | 4922 | 6 mm |

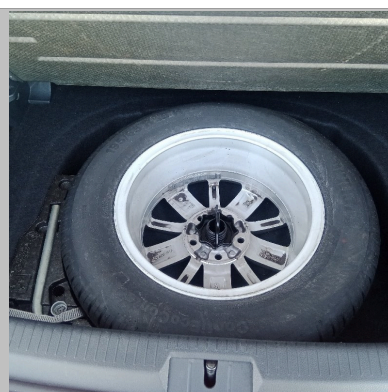
Spare tyre

| | Size | Load/Speed Index | Manufacture | Model | Type* | Production Date | Tread Depth (mm) |
|---|---|---|---|---|---|---|---|
| Spare | 195/65R15 | 91H | Continental | Contact 2 | V | 0000 | 6 mm |

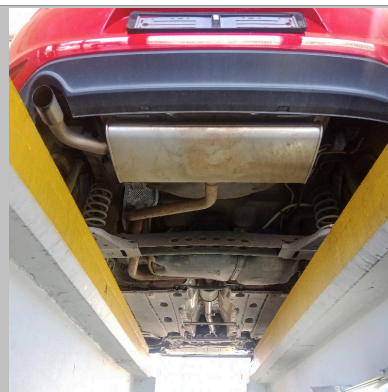
Chassis 2

General Comments: ACCORDING TO THE AGE AND MILEAGE OF THE VEHICLE, NORMAL WEAR AND TEAR MARKS ARE VISIBLE ON THE INTERIOR, EXTERIOR, ELECTRICAL AND MECHANICAL PARTS. Body • Exterior: Minor dents scratches and stone chips  
Undercarriage: Under carriage mostly covered

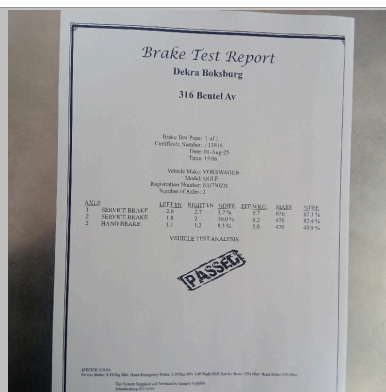
BRAKE REPORT

| | Left | Right | | |
|---|---|---|---|---|
| Front | 2.6 | 2.7 | - | |
| Rear | 1.8 | 2.0 | - | |
| Emergency / Parking | 1.1 | 1.2 | - | |
