## Assignment

## Vehicle Data

| Manufacturer | BMW | Registration Number | HB40WTGP |
| Model | 340I SPORT STEPTRONIC [2015-2019] | Register Number | XWC770W |

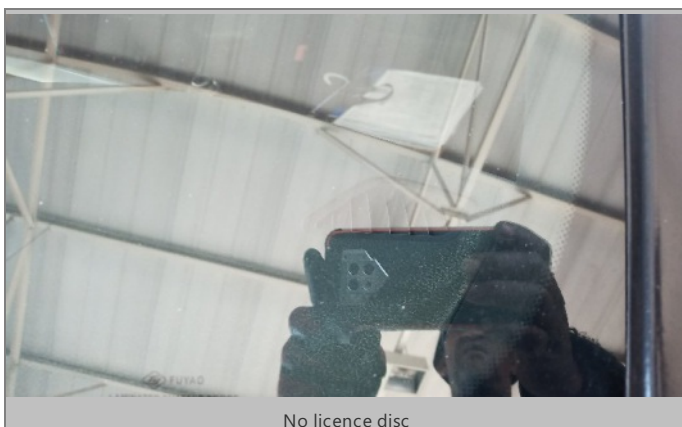
No licence disc

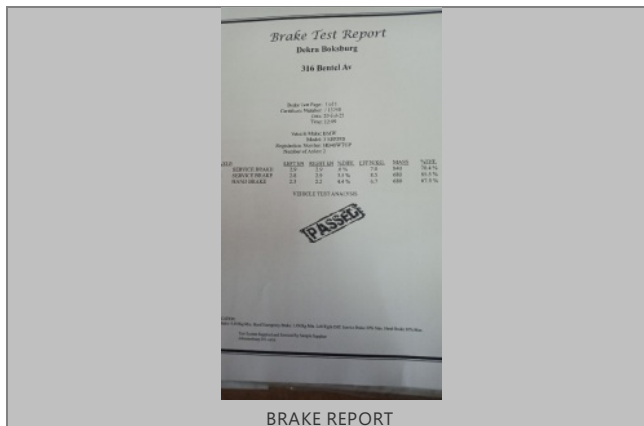
BRAKE REPORT

| | Left | Right | Axle Weight [KG] | Deceleration [m/s <sup>2</sup> ] |
|---|---|---|---|---|
| Front | 2.9 | 2.9 | - | |
| Rear | 2.8 | 2.9 | - | |
| Emergency / Parking | 2.3 | 2.2 | - | |

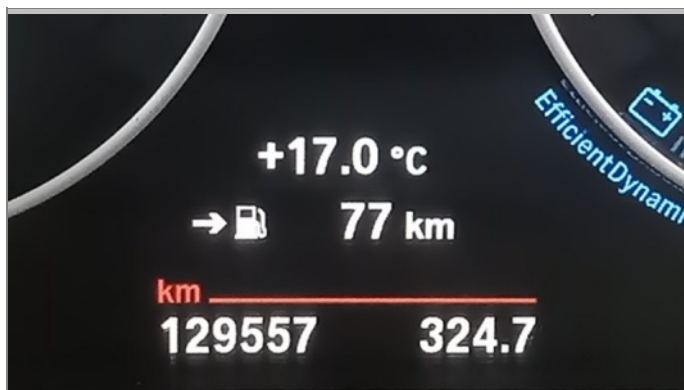
ODOMETER

| Km Reading | 129,557 KM | Fuel | PETROL |

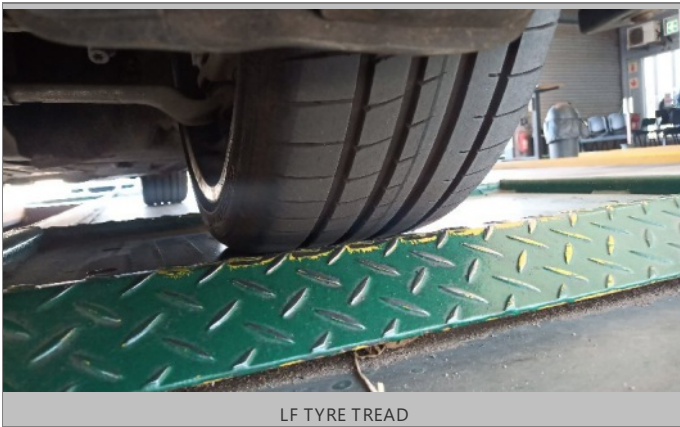
LF TYRE TREAD

| | Size | Load/Speed Index | Manufacture | Model | Type* | Production Date | Tread Depth (mm) |
|---|---|---|---|---|---|---|---|
| Front Left | 225/40R19 | 93Y | Goodyear | Eagle | V | 0424 | 5 mm |

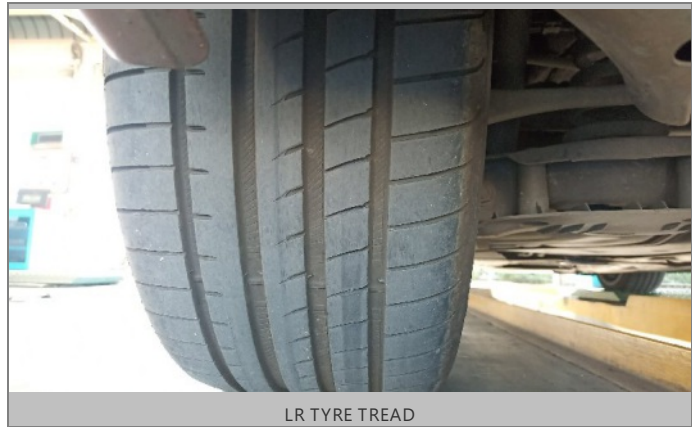
LR TYRE TREAD

| | Size | Load/Speed Index | Manufacture | Model | Type* | Production Date | Tread Depth (mm) |
|---|---|---|---|---|---|---|---|
| Rear Left | 255/35R19 | 93Y | Goodyear | Eagle | V | 3324 | 5 mm |

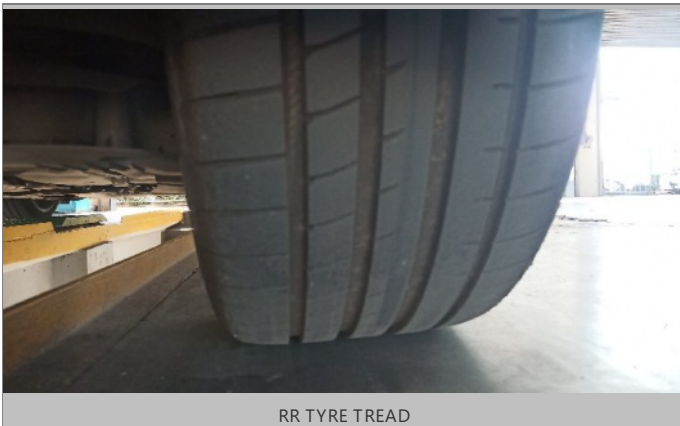
RR TYRE TREAD

| | Size | Load/Speed Index | Manufacture | Model | Type* | Production Date | Tread Depth (mm) |
|---|---|---|---|---|---|---|---|
| Rear Right | 255/35R19 | 96Y | Goodyear | Eagle | V | 3424 | 5 mm |

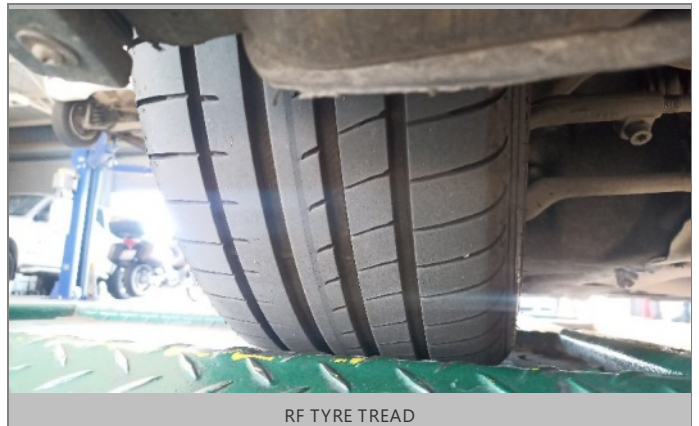
RF TYRE TREAD

| | Size | Load/Speed Index | Manufacture | Model | Type* | Production Date | Tread Depth (mm) |
|---|---|---|---|---|---|---|---|
| Front Right | 225/40R19 | 93Y | Goodyear | Eagle | V | 3324 | 5 mm |
