DEKRA Boksburg  
Bentel Ave - 1459  
BOKSBURG - GT  
011 826 4386

## Assignment

## Vehicle Data

| Manufacturer | FORD | Registration Number | KS57BDGP |

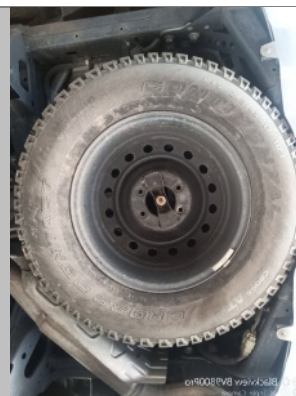
Spare wheel

| | Size | Load/Speed Index | Manufacture | Model | Type* | Production Date | Tread Depth (mm) |
|---|---|---|---|---|---|---|---|
| Spare | 256/65R17 | 112T | Continental | Cross contac | V | 0 | 9 mm |

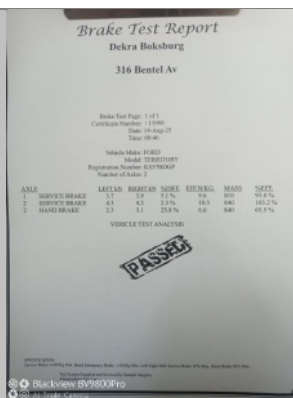
Brake report

| | Left | Right | | |
| | Braking Force [KN] | Braking Force [KN] | Axle Weight [KG] | Deceleration [m/s <sup>2</sup> ] |
| Front | 3.7 | 3.9 | - | |
| Rear | 4.3 | 4.2 | - | |
| Emergency / Parking | 2.3 | 3.1 | - | |

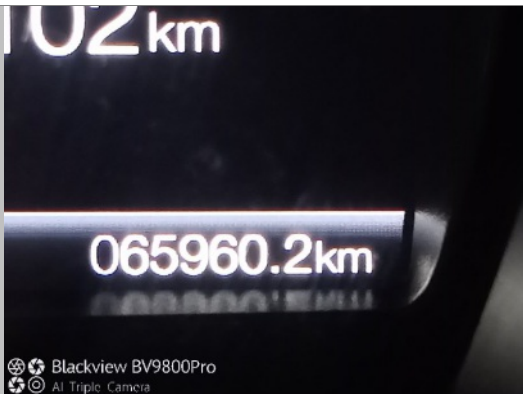
ODOMETER

| Km Reading | 65,960 KM | Fuel | DIESEL |

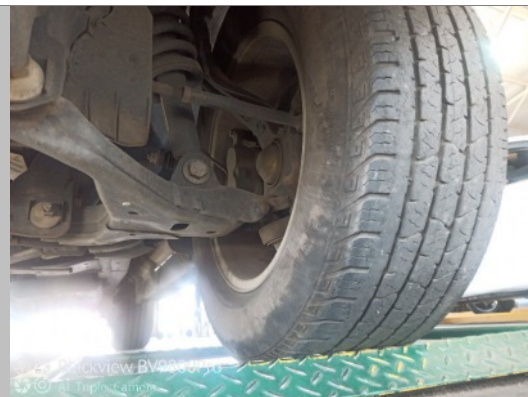
LF TYRE TREAD

| | Size | Load/Speed Index | Manufacture | Model | Type* | Production Date | Tread Depth (mm) |
|---|---|---|---|---|---|---|---|
| Front Left | 265/60R18 | 110T | Continental | Cross contac | V | 2121 | 3 mm |

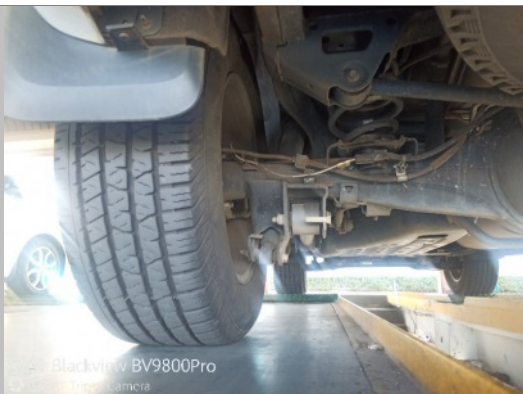
LR TYRE TREAD

| | Size | Load/Speed Index | Manufacture | Model | Type* | Production Date | Tread Depth (mm) |
|---|---|---|---|---|---|---|---|
| Rear Left | 265/60R18 | 110T | Continental | Cross contac | V | 1924 | 6 mm |

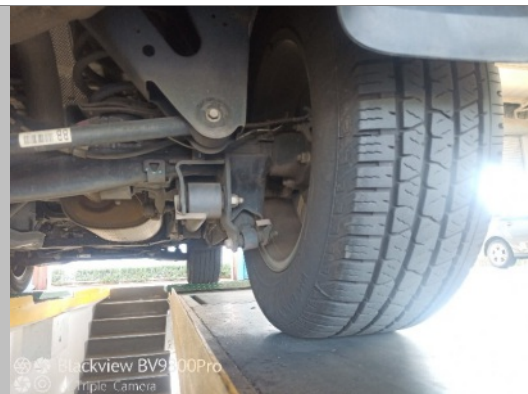
RR TYRE TREAD

| | Size | Load/Speed Index | Manufacture | Model | Type* | Production Date | Tread Depth (mm) |
|---|---|---|---|---|---|---|---|
| Rear Right | 265/60R18 | 110T | Continental | Cross contac | V | 1924 | 6 mm |

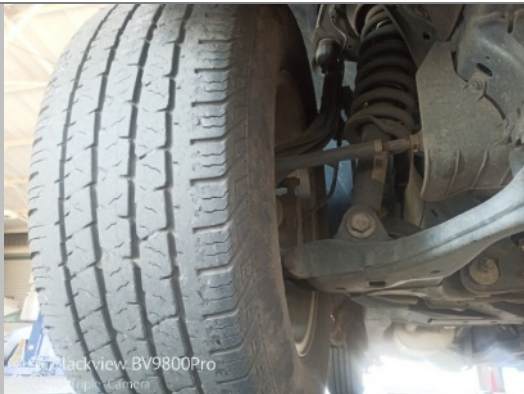
RF TYRE TREAD

| | Size | Load/Speed Index | Manufacture | Model | Type* | Production Date | Tread Depth (mm) |
|---|---|---|---|---|---|---|---|
| Front Right | 265/60R16 | 110T | Continental | Cross contac | V | 2121 | 3 mm |

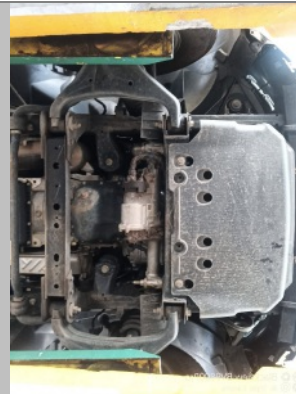
ENGINE 2

Vehicle Dirty  
Engine number – not possible to verify engine number (not visible without dismantling)  
Inspection conditions for the vehicle inspection were sufficient
