Private Client

DEKRA Boksburg  
Bentel Ave - 1459  
BOKSBURG - GT  
011 826 4386

| Manufacturer | TOYOTA | Registration Number | BV28ZJZN |
| Model | AURIS 1.6 XI 5-DR [2013-2015] | Register Number | FPT622L |

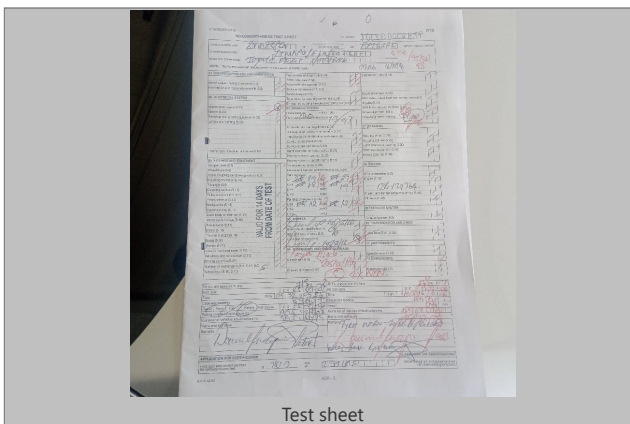
Test sheet

### Brake Test Results

| | Left | Right | | |
|---|---|---|---|---|
| Front | 2.4 | 2.7 | - | |
| Rear | 1.5 | 1.7 | - | |
| Emergency / Parking | 1.2 | 1.2 | - | |

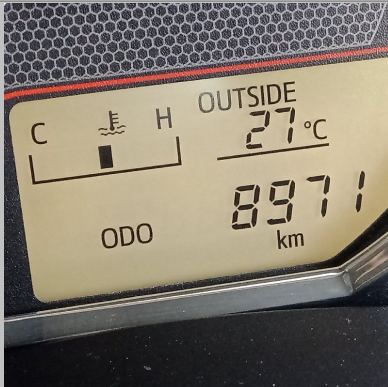
ODOMETER

| Km Reading | 8,971 KM | Fuel | PETROL |

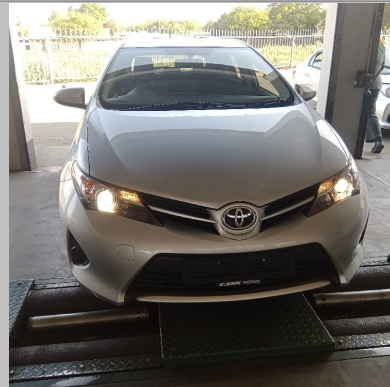
90 DEGREE FRONT

General Comments: Body • Exterior: Minor dents scratches and stone chips  
Undercarriage: Under carriage mostly covered

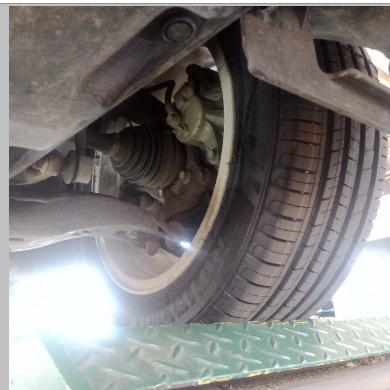
LF TYRE TREAD

| | Size | Load/Speed Index | Manufacture | Model | Type* | Production Date | Tread Depth (mm) |
|---|---|---|---|---|---|---|---|
| Front Left | 205/55R16 | 91V | Royal Black | Royal Mile | V | 2125 | 6 mm |

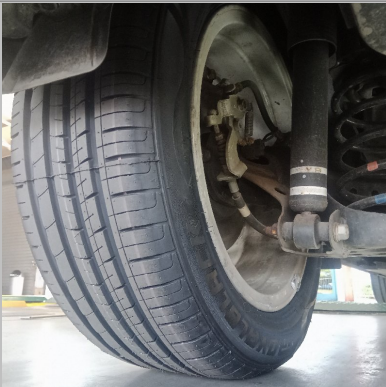
LR TYRE TREAD

| | Size | Load/Speed Index | Manufacture | Model | Type* | Production Date | Tread Depth (mm) |
|---|---|---|---|---|---|---|---|
| Rear Left | 205/55R16 | 91V | Royal Black | Royal Mile | V | 2125 | 6 mm |

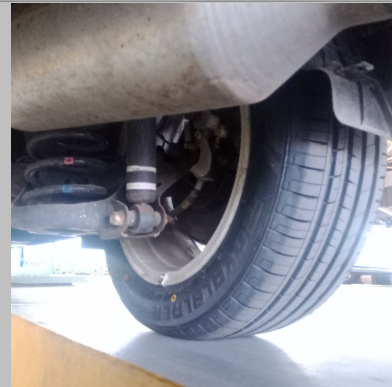
RR TYRE TREAD

| | Size | Load/Speed Index | Manufacture | Model | Type* | Production Date | Tread Depth (mm) |
|---|---|---|---|---|---|---|---|
| Rear Right | 205/55R16 | 91V | Royal Black | Royal Mile | V | 2125 | 6 mm |

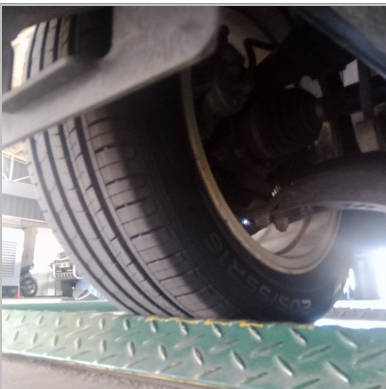
RF TYRE TREAD

| | Size | Load/Speed Index | Manufacture | Model | Type* | Production Date | Tread Depth (mm) |
|---|---|---|---|---|---|---|---|
| Front Right | 205/55R16 | 91V | Royal Black | Royal Mile | V | 2125 | 6 mm |

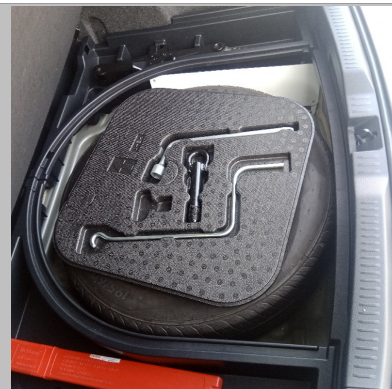
Spare tyre

| | Size | Load/Speed Index | Manufacture | Model | Type* | Production Date | Tread Depth (mm) |
|---|---|---|---|---|---|---|---|
| Spare | 195/60R16 | 89V | Ceat | Secure Drive | V | 0000 | 4 mm |

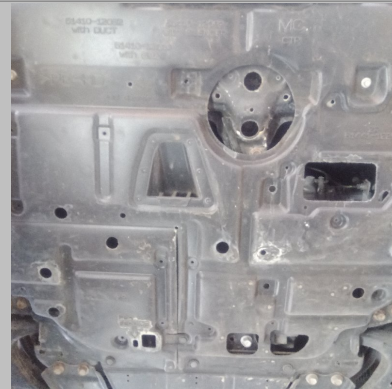
Engine covered
