DEKRA Boksburg  
Bentel Ave - 1459  
BOKSBURG - GT  
011 826 4386

## Assignment

## Vehicle Data

| Model | FIESTA 1.6 ST 3-DR [2013-2018] | Register Number | WXD748W |

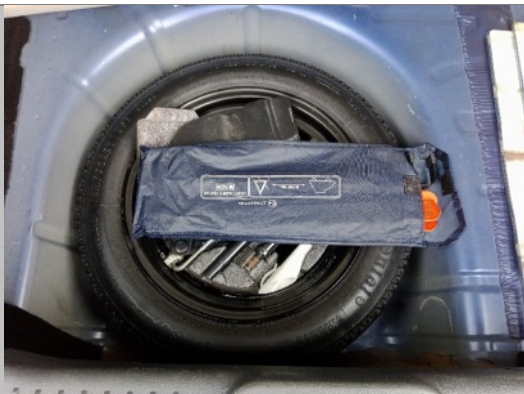
Sparewheel

| | Size | Load/Speed Index | Manufacture | Model | Type* | Production Date | Tread Depth (mm) |
|---|---|---|---|---|---|---|---|
| Spare | T 125/80R15 | 95M | Continental | CST17 | V | 0000 | 2 mm |

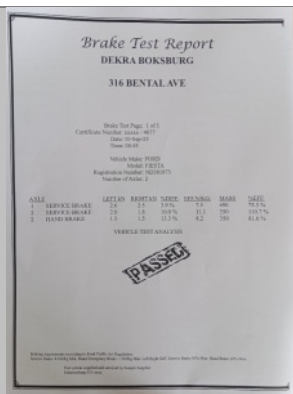
Brake test report

| | Left | Right | | |
|---|---|---|---|---|
| Front | 2.6 | 2.5 | - | |
| Rear | 2.0 | 1.8 | - | |
| Emergency / Parking | 1.3 | 1.5 | - | |

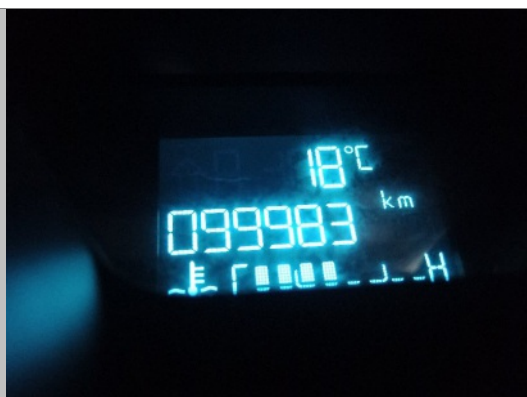
ODOMETER

| Km Reading | 99,983 KM | Fuel | PETROL |

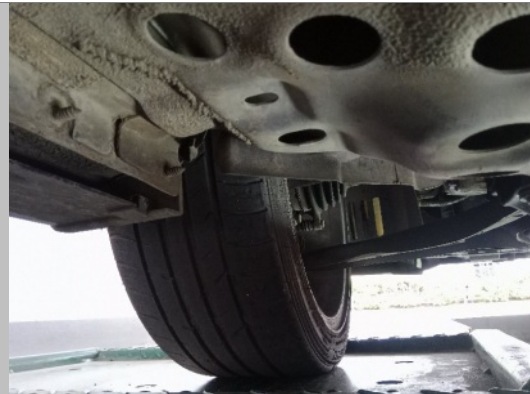
LF TYRE TREAD

| | Size | Load/Speed Index | Manufacture | Model | Type* | Production Date | Tread Depth (mm) |
|---|---|---|---|---|---|---|---|
| Front Left | 205/40R17 | 84W | Dunlop | SP Sport | V | 0321 | 1 mm |

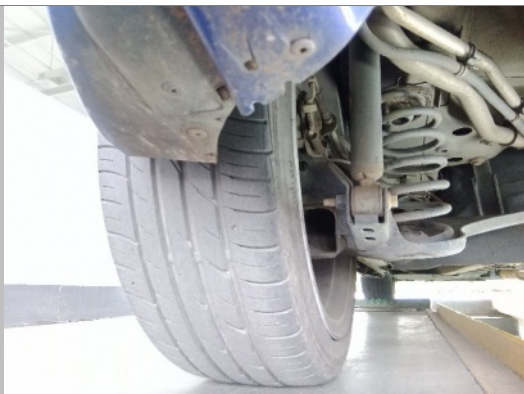
LR TYRE TREAD

| | Size | Load/Speed Index | Manufacture | Model | Type* | Production Date | Tread Depth (mm) |
|---|---|---|---|---|---|---|---|
| Rear Left | 205/40R17 | 84W | Falken | Ziex | V | 1219 | 3 mm |

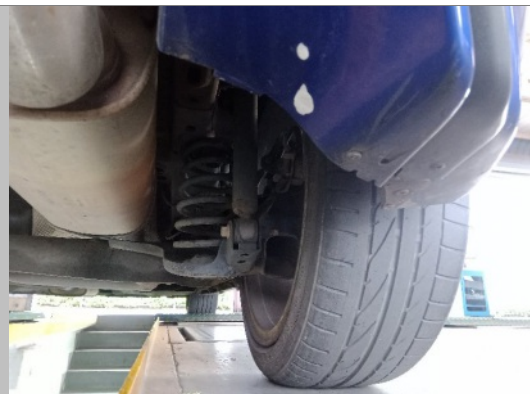
RR TYRE TREAD

| | Size | Load/Speed Index | Manufacture | Model | Type* | Production Date | Tread Depth (mm) |
|---|---|---|---|---|---|---|---|
| Rear Right | 205/40R17 | 84W | Bridgestone | Potenza | V | 4615 | 2 mm |

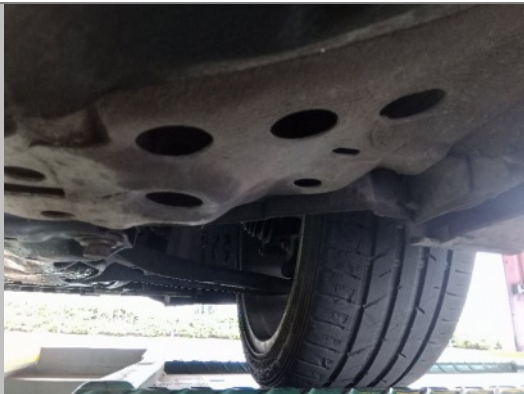
RF TYRE TREAD

| | Size | Load/Speed Index | Manufacture | Model | Type* | Production Date | Tread Depth (mm) |
|---|---|---|---|---|---|---|---|
| Front Right | 205/40R17 | 84W | Dunlop | SP Sport | V | 3820 | 1 mm |
