Private Client

DEKRA Boksburg  
Bentel Ave - 1459  
BOKSBURG - GT  
011 826 4386

## Assignment

| Model | H-1 2.5 VGT 9-S DSL BUS AT [2015-2018] | Register Number | XDV117W |

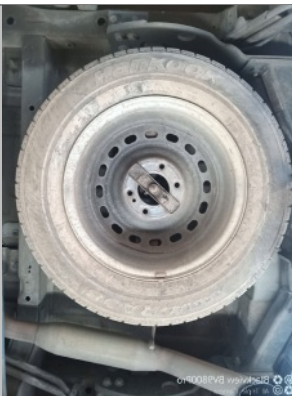
Spare wheel

| | Size | Load/Speed Index | Manufacture | Model | Type* | Production Date | Tread Depth (mm) |
|---|---|---|---|---|---|---|---|
| Spare | 215/70R16 | 108T | Hankook | RA08 | V | 0916 | 3 mm |

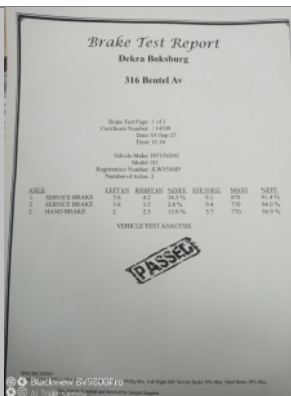
Brake report

Brake efficiency tested during road test.

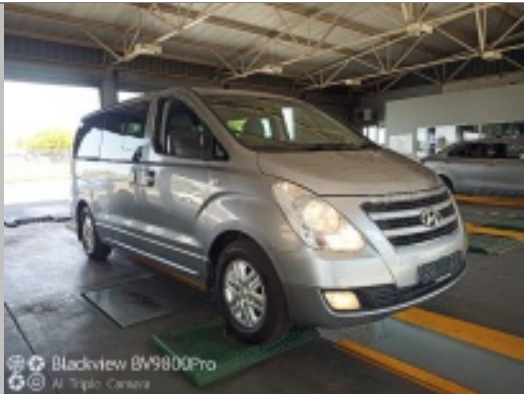
FRONT RIGHT CORNER

General Comments: Body • Exterior: Minor dents, stone chips and or scratches on various body panels.

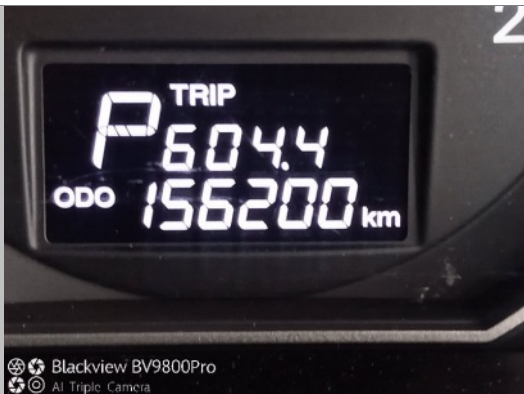
ODOMETER

| Km Reading | 156,200 KM | Fuel | DIESEL |

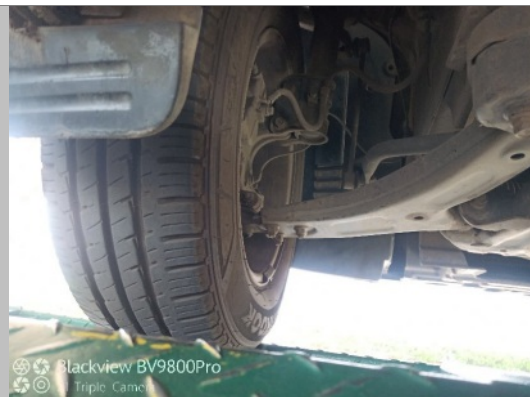
LF TYRE TREAD

| | Size | Load/Speed Index | Manufacture | Model | Type* | Production Date | Tread Depth (mm) |
|---|---|---|---|---|---|---|---|
| Front Left | 215/70R16 | 110S | Hankook | Vantra | V | 4924 | 4 mm |

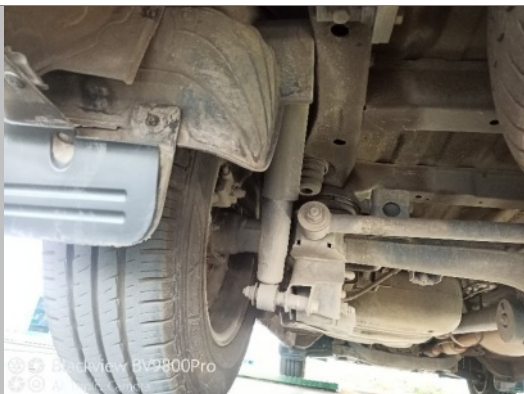
LR TYRE TREAD

| | Size | Load/Speed Index | Manufacture | Model | Type* | Production Date | Tread Depth (mm) |
|---|---|---|---|---|---|---|---|
| Rear Left | 215/70R16 c | 110S | Hankook | Vantra | V | 4924 | 4 mm |

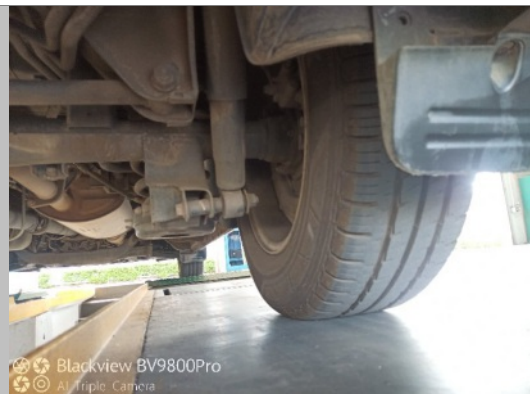
RR TYRE TREAD

| | Size | Load/Speed Index | Manufacture | Model | Type* | Production Date | Tread Depth (mm) |
|---|---|---|---|---|---|---|---|
| Rear Right | 215/70R16 c | 110S | Hankook | Vantra | V | 4924 | 4 mm |

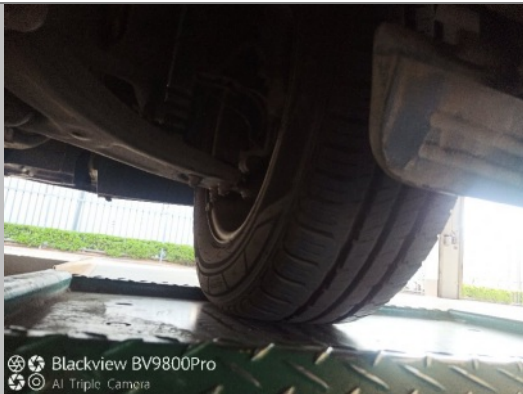
RF TYRE TREAD

| | Size | Load/Speed Index | Manufacture | Model | Type* | Production Date | Tread Depth (mm) |
|---|---|---|---|---|---|---|---|
| Front Right | 215/70R16 c | 110S | Hankook | Vantra | V | 4924 | 4 mm |

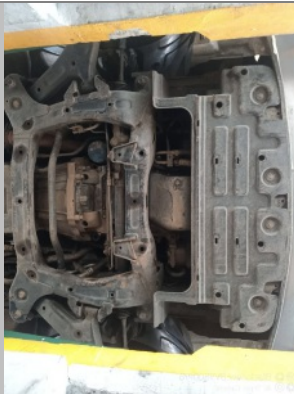
ENGINE 2

Engine number – not possible to verify engine number (not visible without dismantling)
