Private Client

DEKRA Boksburg  
Bentel Ave - 1459  
BOKSBURG - GT  
011 826 4386

| Model | WRANGLER 3.6 RUBICON 10TH ANNIVERSARY 4X4 AT [2013-2014] | Register Number | SZK008W |

## VEHICLE INSPECTION

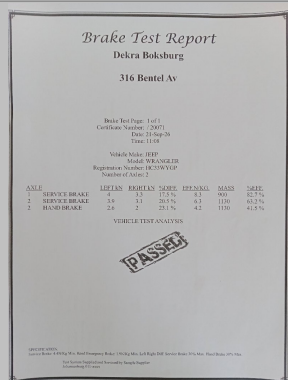
Brake test report

| | Left | Right | | |
| | Braking Force [KN] | Braking Force [KN] | Axle Weight [KG] | Deceleration [m/s <sup>2</sup> ] |
| Front | 4.0 | 3.3 | - | |
| Rear | 3.9 | 3.1 | - | |
| Emergency / Parking | 2.6 | 2 | - | |

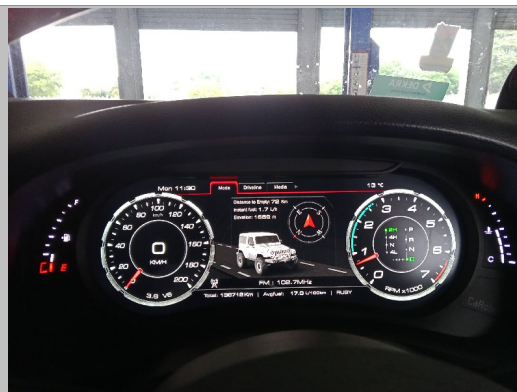
DASHBOARD (W/ ENGINE RUNNING)

General Comments: ACCORDING TO THE AGE AND MILEAGE OF THE VEHICLE, NORMAL WEAR AND TEAR MARKS ARE VISIBLE ON THE INTERIOR, EXTERIOR, ELECTRICAL AND MECHANICAL PARTS. Electrical Components and Instruments: Airconditioning not cooling at time of inspection.

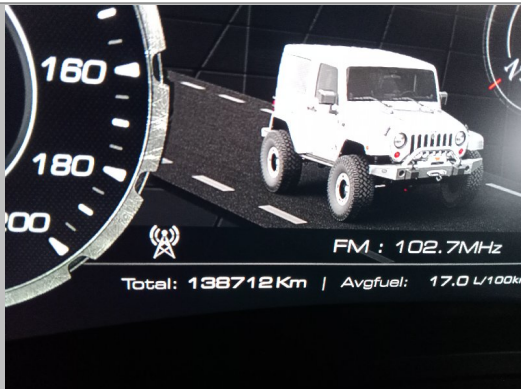
ODOMETER

| Km Reading | 138,712 KM | Fuel | PETROL |

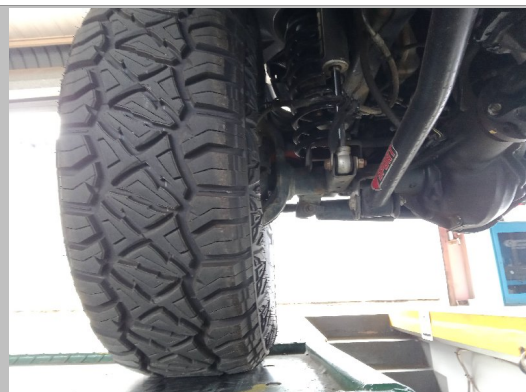
LF TYRE TREAD

| | Size | Load/Speed Index | Manufacture | Model | Type* | Production Date | Tread Depth (mm) |
|---|---|---|---|---|---|---|---|
| Front Left | LT285/70R17 | 116/113Q | I Link | Penterra | V | 3625 | 10 mm |

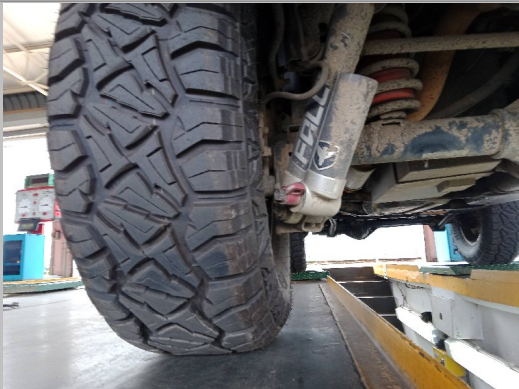
LR TYRE TREAD

| | Size | Load/Speed Index | Manufacture | Model | Type* | Production Date | Tread Depth (mm) |
|---|---|---|---|---|---|---|---|
| Rear Left | LT285/70R17 | 116/113Q | I Link | Penterra | V | 3925 | 10 mm |

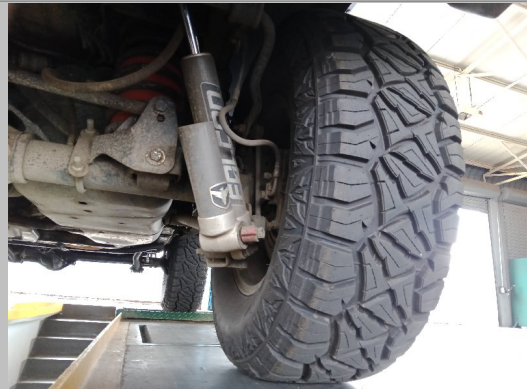
RR TYRE TREAD

| | Size | Load/Speed Index | Manufacture | Model | Type* | Production Date | Tread Depth (mm) |
|---|---|---|---|---|---|---|---|
| Rear Right | LT285/70R17 | 116/113Q | I Link | Penterra | V | 3925 | 10 mm |

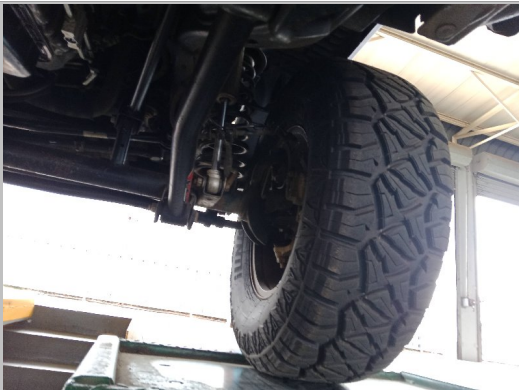
RF TYRE TREAD

| | Size | Load/Speed Index | Manufacture | Model | Type* | Production Date | Tread Depth (mm) |
|---|---|---|---|---|---|---|---|
| Front Right | LT285/70R17 | 116/113Q | I Link | Penterra | V | 3825 | 10 mm |

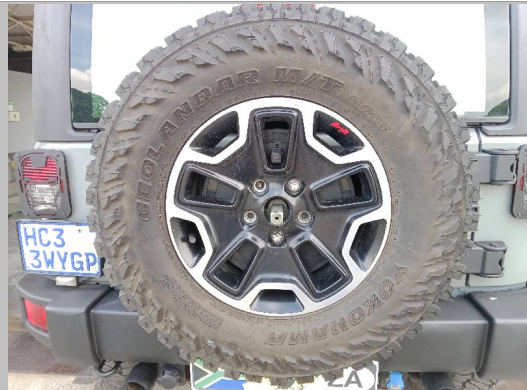
Sparewheel

| | Size | Load/Speed Index | Manufacture | Model | Type* | Production Date | Tread Depth (mm) |
|---|---|---|---|---|---|---|---|
| Spare | LT285/70R17 | 121/118Q | Yokohama | Geolandar | V | 0919 | 13 mm |

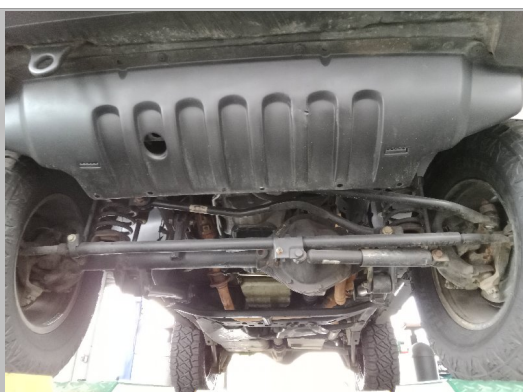
CHASSIS

Undercarriage: Non standard exhaust system fitted. Long range tank fitted.
