DEKRA Boksburg  
Bentel Ave - 1459  
BOKSBURG - GT  
011 826 4386

## Assignment

| Manufacturer | MAHINDRA | Registration Number | NRB14644 |
| Model | XUV 500 2.2 DE W8 MHAWK DSL NEW AGE 7-S AT [2016-2019] | Register Number | XHY663W |

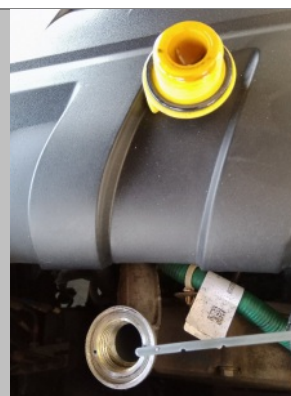
Oil cap and dipstick

General Comments: ACCORDING TO THE AGE AND MILEAGE OF THE VEHICLE, NORMAL WEAR AND TEAR MARKS ON EXTERIOR, INTERIOR AND MECHANICAL PARTS. Engine Compartment: Engine area wet, not dripping.  
Body • Exterior: The nudgebar mounting bracket was loose. Cosmetic spraywork was done to some body panels.  
Undercarriage: Non standard exhaust system fitted.

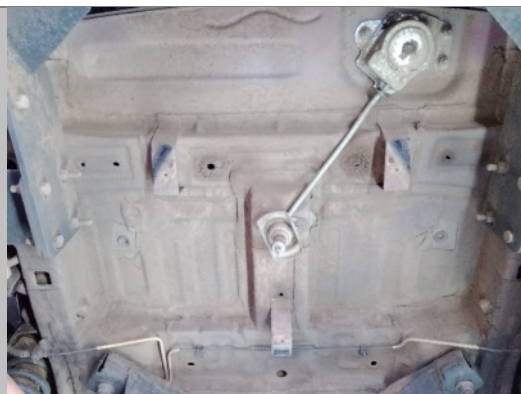
No Sparewheel

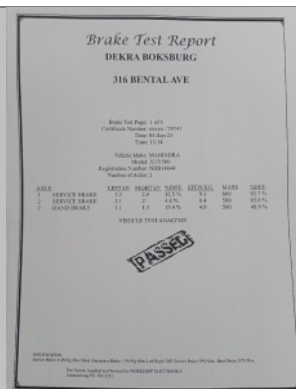
## Brake test report

| | Left | Right | | |
|---|---|---|---|---|
| Front | 3.2 | 2.8 | - | |
| Rear | 2.1 | 2.0 | - | |
| Emergency / Parking | 1.1 | 1.3 | - | |

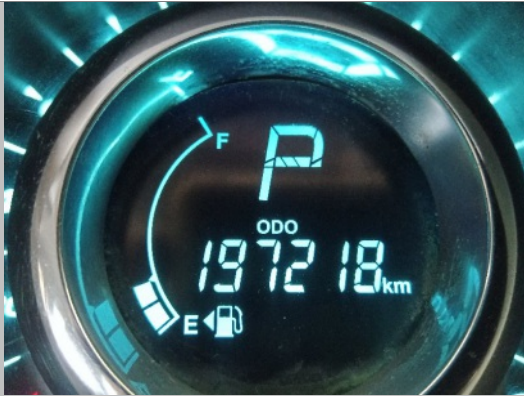
ODOMETER

| Km Reading | 197,218 KM | Fuel | DIESEL |

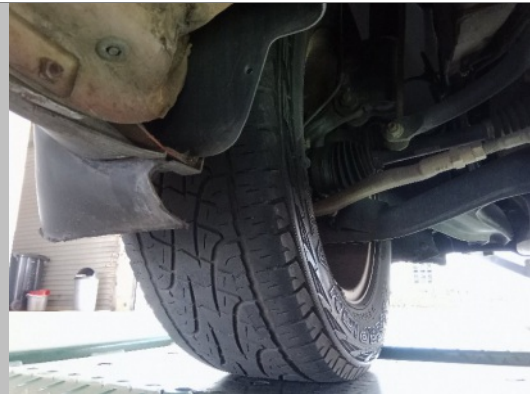
LF TYRE TREAD

| | Size | Load/Speed Index | Manufacture | Model | Type* | Production Date | Tread Depth (mm) |
|---|---|---|---|---|---|---|---|
| Front Left | P235/65R17 | 108H | Pirelli | Scorpion | V | 2221 | 3 mm |

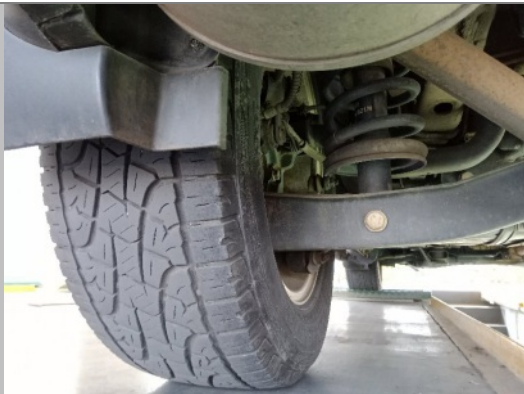
LR TYRE TREAD

| | Size | Load/Speed Index | Manufacture | Model | Type* | Production Date | Tread Depth (mm) |
|---|---|---|---|---|---|---|---|
| Rear Left | P235/65R17 | 108H | Pirelli | Scorpion | V | 3620 | 5 mm |

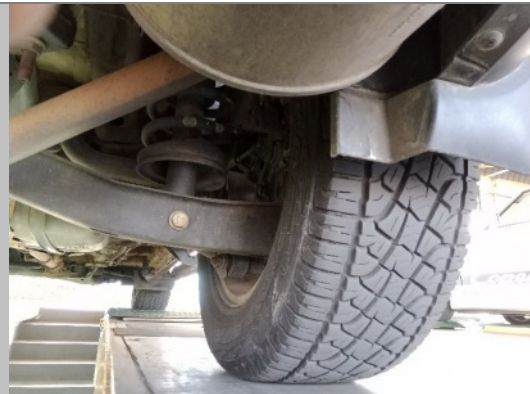
RR TYRE TREAD

| | Size | Load/Speed Index | Manufacture | Model | Type* | Production Date | Tread Depth (mm) |
|---|---|---|---|---|---|---|---|
| Rear Right | P235/65R17 | 108H | Pirelli | Scorpion | V | 2221 | 5 mm |

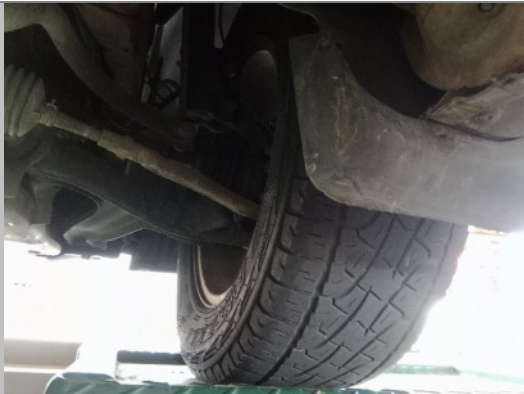
RF TYRE TREAD

| | Size | Load/Speed Index | Manufacture | Model | Type* | Production Date | Tread Depth (mm) |
|---|---|---|---|---|---|---|---|
| Front Right | P235/65R17 | 108H | Pirelli | Scorpion | V | 2221 | 3 mm |

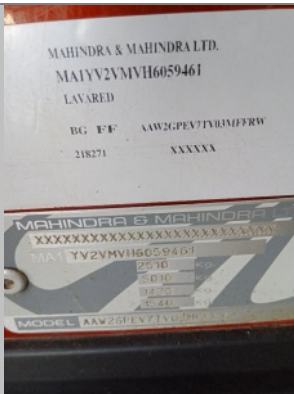
VIN PLATE OR STICKER

| VIN | MA1YV2VMVH6059461 | Date Of First Licensing | |
