Private Client

DEKRA Boksburg  
Bentel Ave - 1459  
BOKSBURG - GT  
011 826 4386

| Manufacturer | MITSUBISHI | Registration Number | KWG486MP |
| Model | PAJERO SPORT | Register Number | ZTD919W |

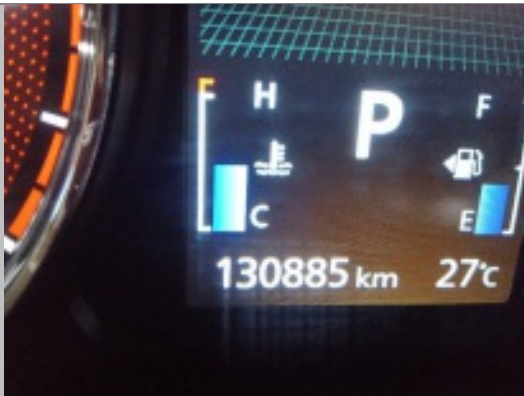
ODOMETER

| Km Reading | 130,885 KM | Fuel | DIESEL |

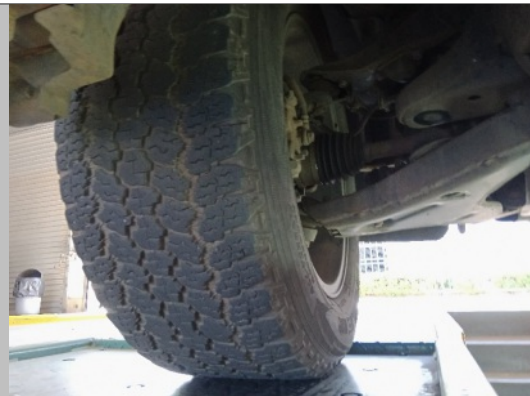
LF TYRE TREAD

| | Size | Load/Speed Index | Manufacture | Model | Type* | Production Date | Tread Depth (mm) |
|---|---|---|---|---|---|---|---|
| Front Left | 265/60R | 110H | Goodyear | Wrangler | V | 4321 | 4 mm |

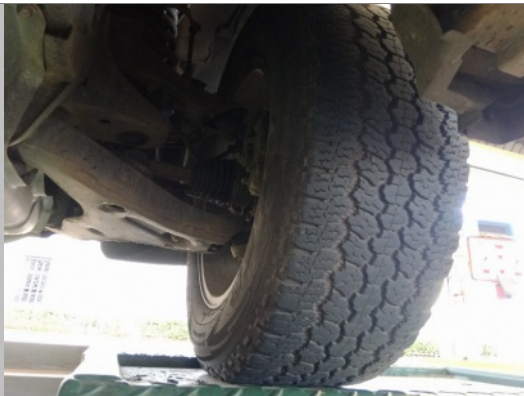
RF TYRE TREAD

| | Size | Load/Speed Index | Manufacture | Model | Type* | Production Date | Tread Depth (mm) |
|---|---|---|---|---|---|---|---|
| Front Right | 265/60R18 | 110H | Goodyear | Wrangler | V | 2222 | 4 mm |

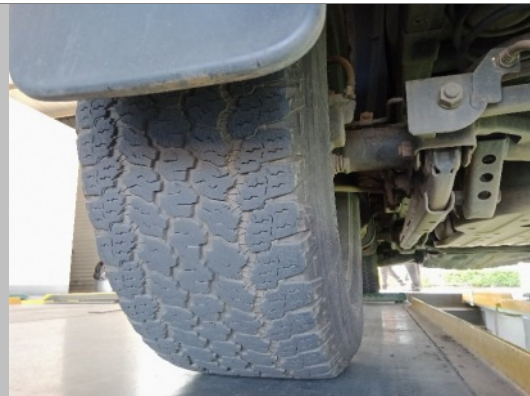
LR TYRE TREAD

| | Size | Load/Speed Index | Manufacture | Model | Type* | Production Date | Tread Depth (mm) |
|---|---|---|---|---|---|---|---|
| Rear Left | 265/60R18 | 110H | Goodyear | Wrangler | V | 4321 | 4 mm |

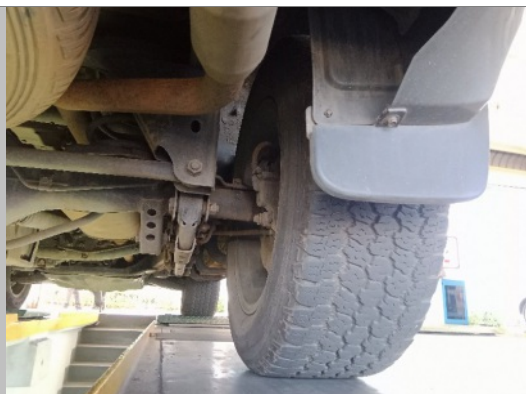
RR TYRE TREAD

| | Size | Load/Speed Index | Manufacture | Model | Type* | Production Date | Tread Depth (mm) |
|---|---|---|---|---|---|---|---|
| Rear Right | 265/60R18 | 110H | Goodyear | Wrangler | V | 0222 | 4 mm |

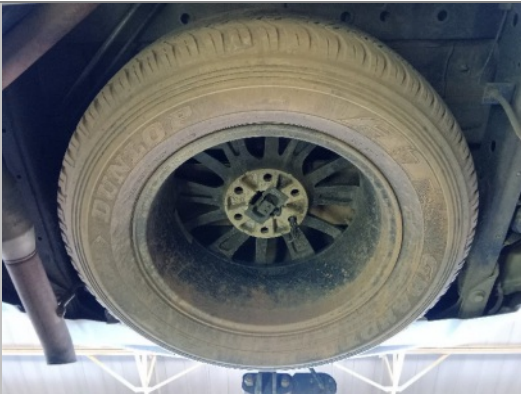
SPARE WHEEL

| | Size | Load/Speed Index | Manufacture | Model | Type* | Production Date | Tread Depth (mm) |
|---|---|---|---|---|---|---|---|
| Spare | 265/60R18 | 110H | Dunlop | Grandtrek | V | 0000 | 5 mm |

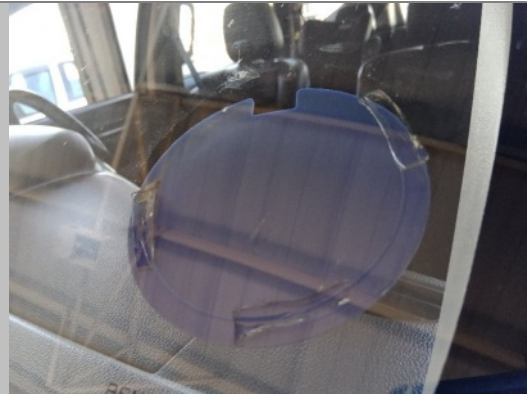
NO LICENCE DISC

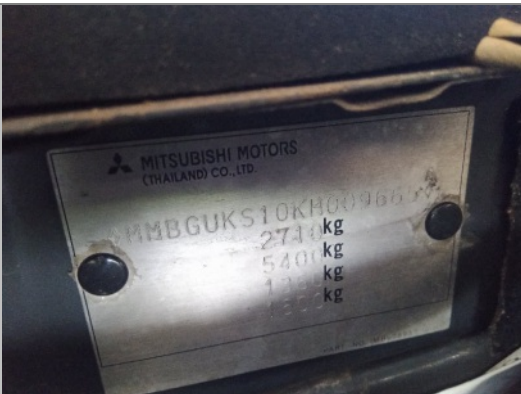
VIN PLATE OR STICKER

| VIN | MMBGUKS10KH009665 | Date Of First Licensing | |

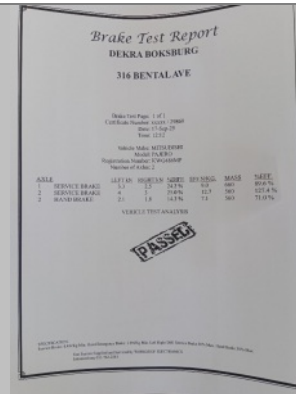
BRAKE TEST REPORT

| | Left | Right | | |
|---|---|---|---|---|
| Front | 3.3 | 2.5 | - | |
| Rear | 4.0 | 3.0 | - | |
| Emergency / Parking | 2.1 | 1.8 | - | |
