DEKRA Boksburg  
Bentel Ave - 1459  
BOKSBURG - GT  
011 826 4386

## Assignment

| Manufacturer | TOYOTA | Registration Number | FN93BXGP |
| Model | 86 2.0 SPORTS COUPE HIGH [2012-2014] | Register Number | FFZ937L |

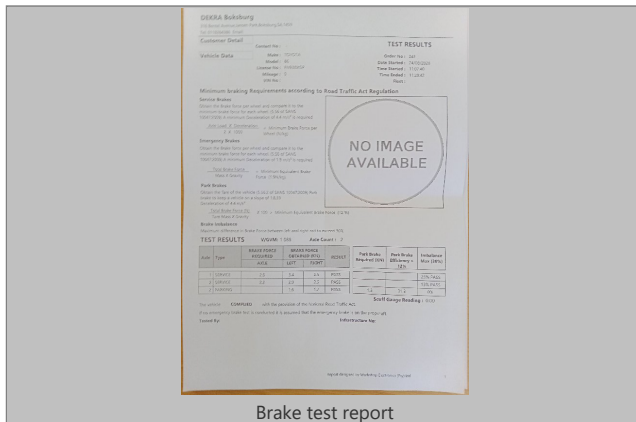
Brake test report

### Brake Test Results

| | Left | Right | | |
| | Braking Force [KN] | Braking Force [KN] | Axle Weight [KG] | Deceleration [m/s <sup>2</sup> ] |
| Front | 3.4 | 2.5 | - | |
| Rear | 2.9 | 2.5 | - | |
| Emergency / Parking | 1.6 | 1.7 | - | |

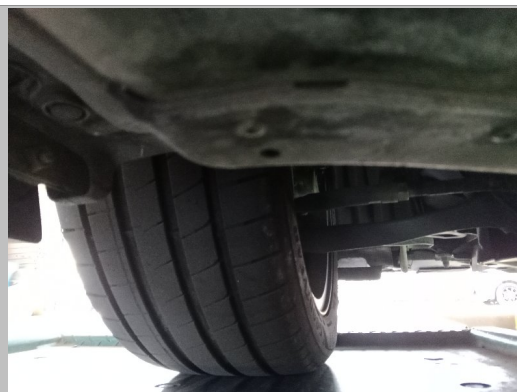
LF TYRE TREAD

| | Size | Load/Speed Index | Manufacture | Model | Type* | Production Date | Tread Depth (mm) |
|---|---|---|---|---|---|---|---|
| Front Left | 235/45R17 | 97Y | Goodyear | Eagle | V | 0322 | 3 mm |

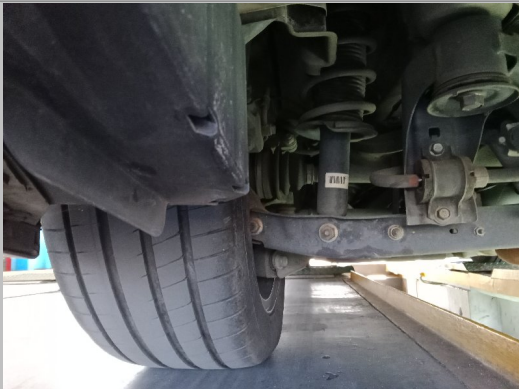
LR TYRE TREAD

| | Size | Load/Speed Index | Manufacture | Model | Type* | Production Date | Tread Depth (mm) |
|---|---|---|---|---|---|---|---|
| Rear Left | 235/45R17 | 97Y | Goodyear | Eagle | V | 0322 | 3 mm |

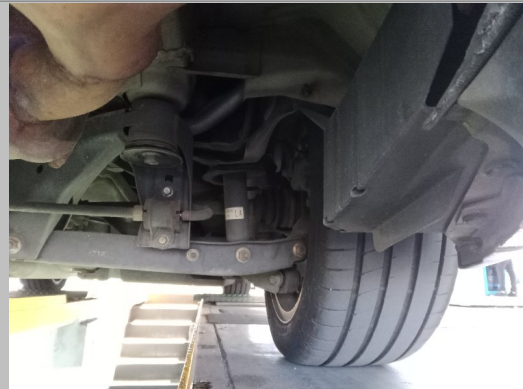
RR TYRE TREAD

| | Size | Load/Speed Index | Manufacture | Model | Type* | Production Date | Tread Depth (mm) |
|---|---|---|---|---|---|---|---|
| Rear Right | 235/45R17 | 97Y | Goodyear | Eagle | V | 0322 | 3 mm |

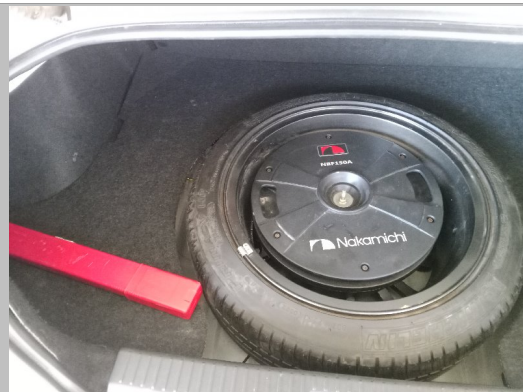
Sparewheel

| | Size | Load/Speed Index | Manufacture | Model | Type* | Production Date | Tread Depth (mm) |
|---|---|---|---|---|---|---|---|
| Spare | 215/45R17 | 87W | Michelin | Primacy | V | 0000 | 5 mm |

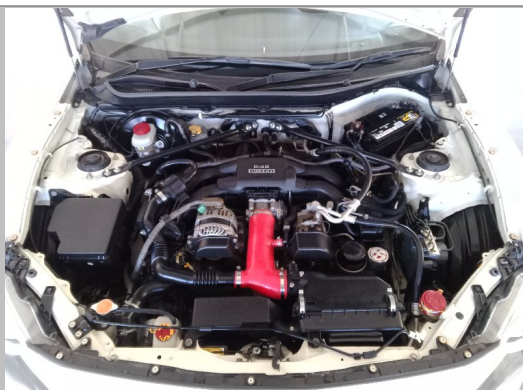
ENGINE 1

General Comments: ACCORDING TO THE AGE AND MILEAGE OF THE VEHICLE, NORMAL WEAR AND TEAR MARKS ARE VISIBLE ON THE INTERIOR, EXTERIOR, ELECTRICAL AND MECHANICAL PARTS. Engine Compartment: Engine, gearbox and undercarriage mostly covered underneath.  
Undercarriage: Non standard exhaust system fitted.  
Road Test: Steering operation noisy during road test (Not excessive)

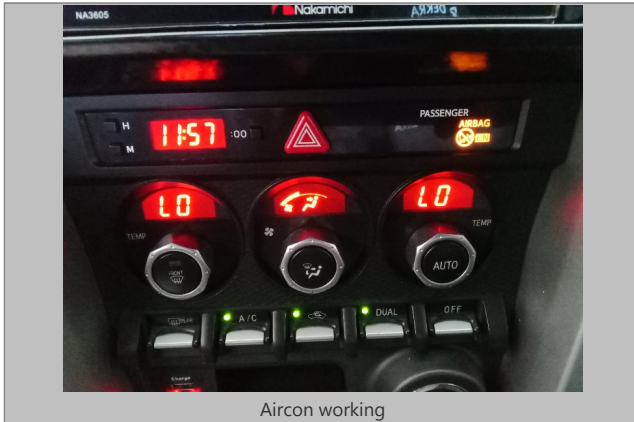
Aircon working
