DEKRA Boksburg
Bentel Ave - 1459
BOKSBURG - GT
011 826 4386

Vehicle Type	PASSENGER VEHICLE	Registered Owner	
Manufacturer	FIAT	Registration Number	CY282326
Model	PALIO 1.6	Register Number	DXJ161S
VIN	AFZ178F7101531110	Date Of First Licensing	
Engine Number	178D20110713477	Last COR	04/02/2026
Doors	4	License Expiry Date	
Color	WHITE	Power / Displacement	74KW/1581CCM
Year Model	2005	Paint Finish	C - COMMON
Km Reading	91,015 KM	Fuel	PETROL
Cab / Body Type	HATCHBACK	Transmission	MANUAL

VEHICLE INSPECTION

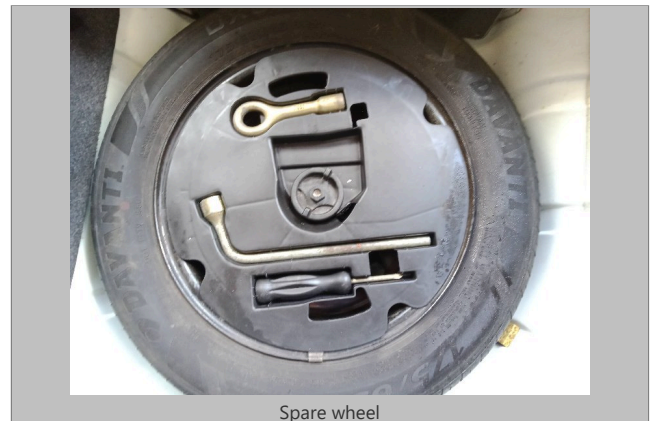
Spare wheel

Size	Load/Speed Index	Manufacture	Model	Type*	Production Date	Tread Depth (mm)
Front Left	175/65/14	82T	Hilo	Genyses	V	3825	5 mm
Front Right	175/65/14	86T	Hilo	Genyses	V	2025	5 mm
Rear Left	175/65/14	82T	Hilo	Genyses	V	3825	6 mm
Rear Right	175/65/14	82T	Hilo	Genyses	V	3825	0 mm
Spare	175/65/14	82T	Davanti	DX390	V	0000	2 mm

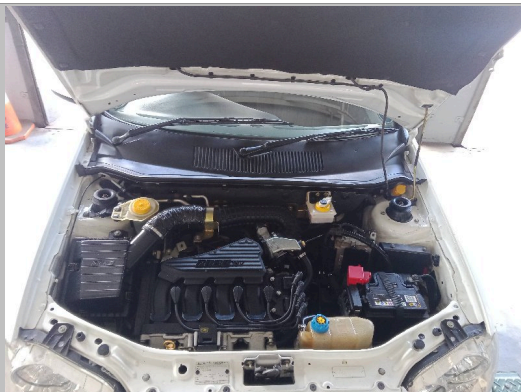
ENGINE 1

Engine number – not possible to verify engine number (not visible without dismantling)
Inspection conditions for the vehicle inspection were sufficient
