DEKRA Boksburg  
Bentel Ave - 1459  
BOKSBURG - GT  
011 826 4386

Vehicle Type	PASSENGER VEHICLE	Registered Owner	CBK CBK MOTORS
Manufacturer	AUDI	Registration Number	KHK403NW
Model	A5	Register Number	DNW839K
VIN	WUAZZZ8T7BA902340	Date Of First Licensing	
Engine Number		Last COR	2026/03/19
Doors	2	License Expiry Date	
Color	SILVER	Power / Displacement	331kW/4163cc
Year Model	2011	Paint Finish	M - METALLIC
Km Reading	68,644 KM	Fuel	PETROL
Cab / Body Type	COUPE	Transmission	AUTOMATIC

**VEHICLE INSPECTION**

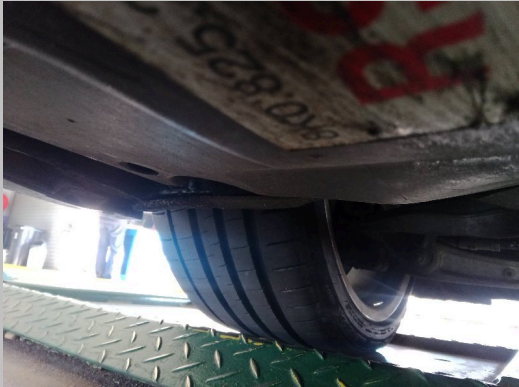
LF TYRE TREAD

Size	Load/Speed Index	Manufacture	Model	Type*	Production Date	Tread Depth (mm)
Front Left	255/35/19	96Y	Dunlop	SP Sport Max	V	1725	5 mm
Front Right	255/35/19	96Y	Dunlop	SP Sport Max	V	1725	5 mm
Rear Left	255/35/19	96Y	Dunlop	SP Sport Max	V	1725	5 mm
Rear Right	255/35/19	96Y	Dunlop	SP Sport Max	V	1725	5 mm
