DEKRA Boksburg  
Bentel Ave - 1459  
BOKSBURG - GT  
011 826 4386

## Assignment

| Model | FIESTA 1.0 ECOBOOST TREND 5-DR POWERSHIFT [2013-2018] | Register Number | TTW018W |

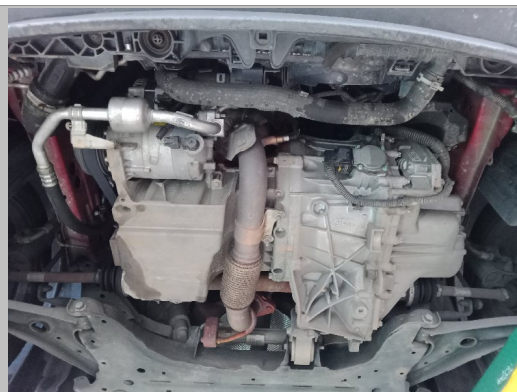
ENGINE 2

General Comments: ACCORDING TO THE AGE AND MILEAGE OF THE VEHICLE, NORMAL WEAR AND TEAR MARKS ARE VISIBLE ON THE INTERIOR, EXTERIOR, ELECTRICAL AND MECHANICAL PARTS. Electrical Components and Instruments: Front washer jets not spraying at time of inspection.  
Body • Exterior: Minor dents, scratches and stone chips on some body panels. Cosmetical enhancements done to some body panels.  
Axle and Suspension: Rear rebound rubber seats slightly perished.  
Undercarriage: Lower gearbox mounting bush slightly perished.
