Private Client

DEKRA Boksburg
Bentel Ave - 1459
BOKSBURG - GT
011 826 4386

Vehicle Type	PASSENGER VEHICLE	Registered Owner	CBK MOTORS
Manufacturer	TOYOTA	Registration Number	DP82FCGP
Model	ETIOS CROSS 1.5 5-DR [2014-2015]	Register Number	FYB524L
VIN	MBJM29BT402022118	Date Of First Licensing	
Engine Number	2NRD076562	Last COR	13/01/2026
Doors	5	License Expiry Date	30/09/2026
Color	GREY	Power / Displacement	66kw 1496ccm
Year Model	2015	Paint Finish	M - METALLIC
Km Reading	87,448 KM	Fuel	PETROL
Cab / Body Type	HATCHBACK	Transmission	MANUAL

VEHICLE INSPECTION

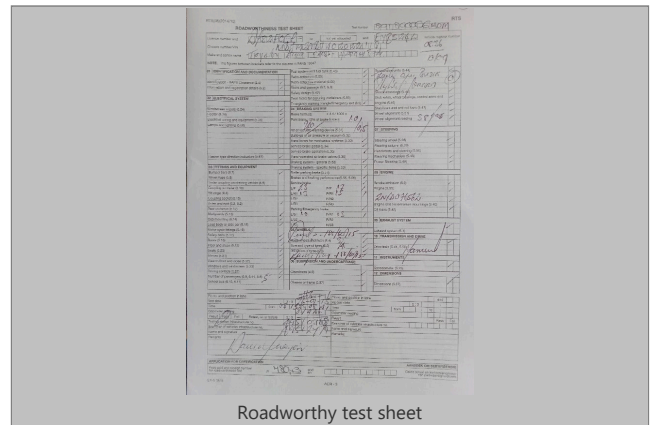
Brake test report

Left	Right		
	Braking Force [KN]	Braking Force [KN]	Axle Weight [KG]	Deceleration [m/s ²]
Front	2.3	1.7	-	
Rear	1.3	1.5	-	
Emergency / Parking	1	1.3	-
