Private Client

DEKRA Boksburg
Bentel Ave - 1459
BOKSBURG - GT
011 826 4386

Vehicle Type	PASSENGER VEHICLE	Registered Owner	CBK MOTORS
Manufacturer	BMW	Registration Number	MB88TCGP
Model	318I STEPTRONIC [2015-2019]	Register Number	YHR674W
VIN	WBA8E36070NU81555	Date Of First Licensing	
Engine Number	F7201809	Last COR	30/03/2026
Doors	4	License Expiry Date	
Color	SILVER	Power / Displacement	100Kw. 1499Ccm
Year Model	2018	Paint Finish	M - METALLIC
Km Reading	65,160 KM	Fuel	PETROL
Cab / Body Type	SEDAN	Transmission	AUTOMATIC

VEHICLE INSPECTION

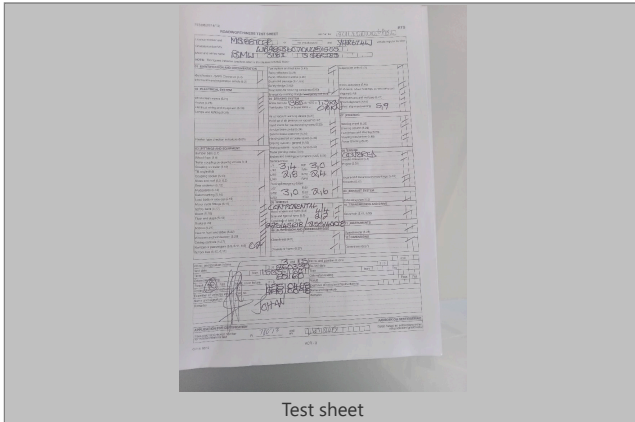
Test sheet

Left	Right		
	Braking Force [KN]	Braking Force [KN]	Axle Weight [KG]	Deceleration [m/s ²]
Front	3.4	3.0	-	
Rear	2.8	2.4	-	
Emergency / Parking	3	2.6	-

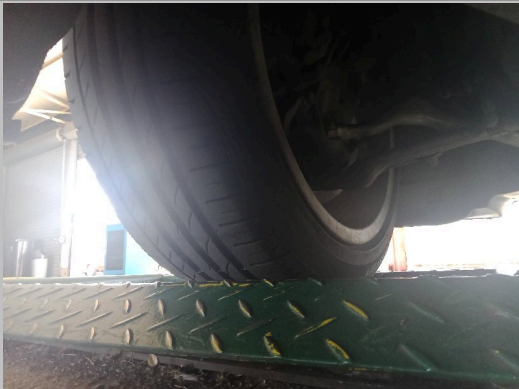
LF TYRE TREAD

Size	Load/Speed Index	Manufacture	Model	Type*	Production Date	Tread Depth (mm)
Front Left	225/45R18	91Y	Continental	Contact 5	V	4222	4 mm
Front Right	225/45R18	91Y	Continental	Contact 5	V	0623	4 mm
Rear Left	255/40R18	95Y	Continental	Contact 5	V	3517	2 mm
Rear Right	255/40R18	95Y	Continental	Contact 5	V	3517	2 mm

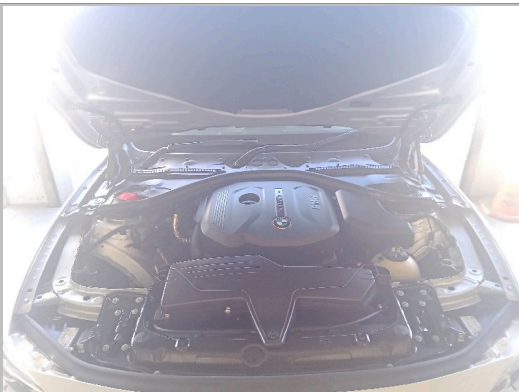
ENGINE 1

Engine number – not possible to verify engine number (not visible without dismantling)
Inspection conditions for the vehicle inspection were sufficient

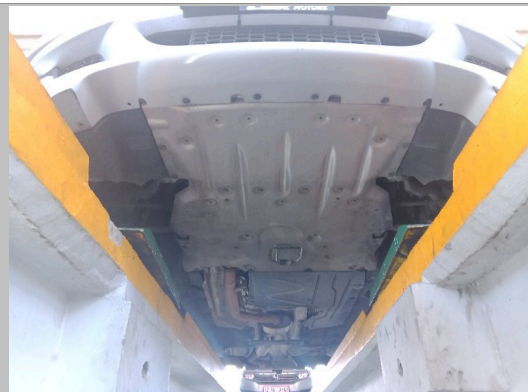
CHASSIS

General Comments: ACCORDING TO AGE AND MILEAGE OF VEHICLE NORMAL WEAR AND TEAR ON INTERIOR, EXTERIOR, ELECTRICAL AND MECHANICAL PARTS. Body • Exterior: Minor dents scratches and stone chips
Undercarriage: Under carriage mostly covered
