Private Client

DEKRA Boksburg
Bentel Ave - 1459
BOKSBURG - GT
011 826 4386

Vehicle Type	PASSENGER VEHICLE	Registered Owner	CBK MOTORS
Manufacturer	HYUNDAI	Registration Number	JZ90ZDGP
Model	H1 9 SEATER	Register Number	ZJL483W
VIN	KMHW81KMKU020366	Date Of First Licensing	
Engine Number	D4CBJ625978	Last COR	16/02/2026
Doors	5	License Expiry Date	31/05/2026
Color	SILVER	Power / Displacement	126Kw/2497Cc
Year Model	2018	Paint Finish	M - METALLIC
Km Reading	85,605 KM	Fuel	DIESEL
Cab / Body Type	OTHERS	Transmission	AUTOMATIC

VEHICLE INSPECTION

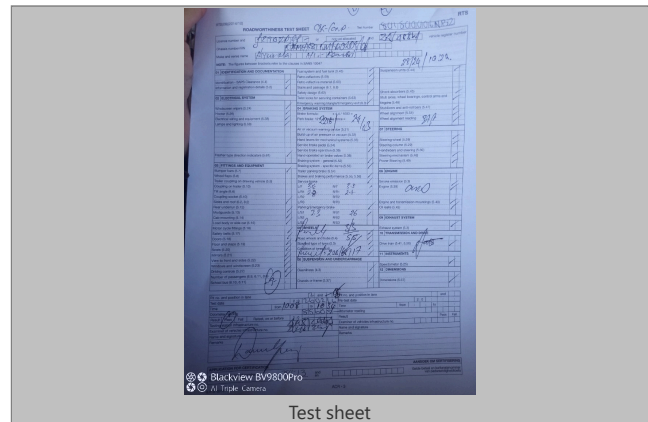
Brake report

Left	Right		
	Braking Force [KN]	Braking Force [KN]	Axle Weight [KG]	Deceleration [m/s ²]
Front	3.4	3.5	-	
Rear	2.8	2.7	-	
Emergency / Parking	2.3	2.6	-

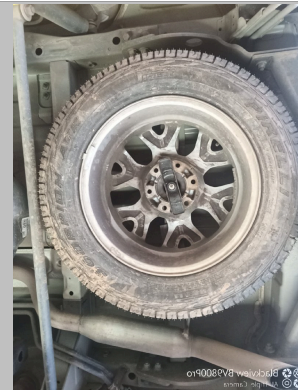
Spare wheel

Size	Load/Speed Index	Manufacture	Model	Type*	Production Date	Tread Depth (mm)
Front Left	225/65R17	106H	Pirelli	Scorpio	V	3321	3 mm
Front Right	225/65R17	106H	Pirelli	Scorpio	V	3221	3 mm
Rear Left	225/65R17	106H	Pirelli	Scorpio	V	3221	5 mm
Rear Right	225/65R17	106H	Pirelli	Scorpio	V	3421	5 mm
Spare	225/65R17	106H	Pirelli	Scorpio	V	0000	5 mm
