Private Client

DEKRA Boksburg
Bentel Ave - 1459
BOKSBURG - GT
011 826 4386

VEHICLE INSPECTION

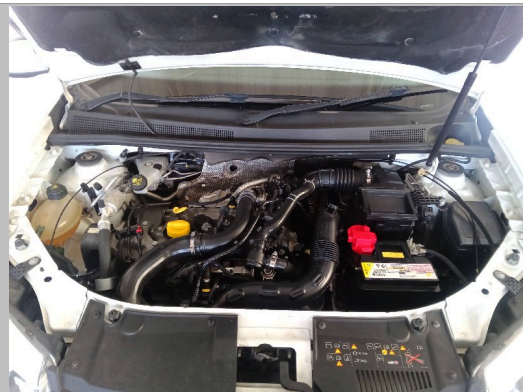
ENGINE 1

General Comments: ACCORDING TO AGE AND MILEAGE OF VEHICLE NORMAL WEAR AND TEAR ON INTERIOR, EXTERIOR, ELECTRICAL AND MECHANICAL PARTS. Engine Compartment: Engine and gearbox partly covered underneath.
Electrical Components and Instruments: Washer jets not spraying at time of inspection.
Body • Exterior: Minor dents, scratches, and stonechips on some body panels. Cosmetic spraywork done to some body panels.
Tyres and Rims: Hubcaps damaged
