Private Client

## Assignment

## Vehicle Data

| Manufacturer | VOLKSWAGEN | Registration Number | CF67LXZN |

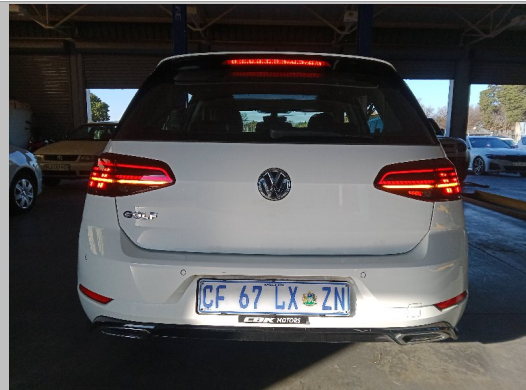
90 DEGREE REAR

General Comments: ACCORDING TO AGE AND MILEAGE OF VEHICLE NORMAL WEAR AND TEAR ON INTERIOR, EXTERIOR, ELECTRICAL AND MECHANICAL PARTS. Engine Compartment: The engine and gearbox are mostly covered underneath.  
Body • Exterior: Residual traces of cosmetic repairs done to some body panels. Rear bumper insert missing.  
Brakes: Brake discs slightly dished.
