Private Client

DEKRA Boksburg
Bentel Ave - 1459
BOKSBURG - GT
011 826 4386

Vehicle Type	PASSENGER VEHICLE	Registered Owner	CBK MOTORS CBK MOTORS
Manufacturer	SUZUKI	Registration Number	CFM851388
Model	VITARA BREZZA 1.5 GL AT [2021-2024]	Register Number	DKS952X
VIN	MA3NYFJ1S00889568	Date Of First Licensing	
Engine Number	K15BN4220051	Last COR	19/06/2026
Doors	5	License Expiry Date	31/07/2026
Color	SILVER	Power / Displacement	77Kw/1462Cc
Year Model	2022	Paint Finish	M - METALLIC
Km Reading	87,349 KM	Fuel	PETROL
Cab / Body Type	HATCHBACK	Transmission	AUTOMATIC

VEHICLE INSPECTION

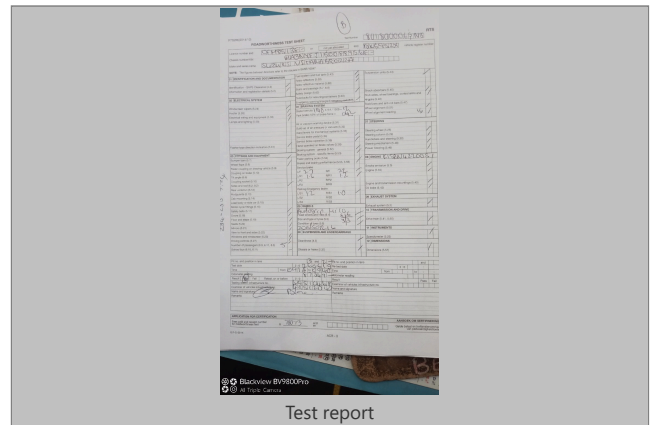
Brake report

Left	Right		
	Braking Force [KN]	Braking Force [KN]	Axle Weight [KG]	Deceleration [m/s ²]
Front	2.7	2.2	-	
Rear	1.6	1.2	-	
Emergency / Parking	1.2	1	-
