Private Client

DEKRA Boksburg  
Bentel Ave - 1459  
BOKSBURG - GT  
011 826 4386

| Manufacturer | VOLKSWAGEN | Registration Number | CNP884L |
| Model | TIGUAN 2.0 TDI TREND&FUN BLUEMOTION DSL [2011-2015] | Register Number | FFN515K |

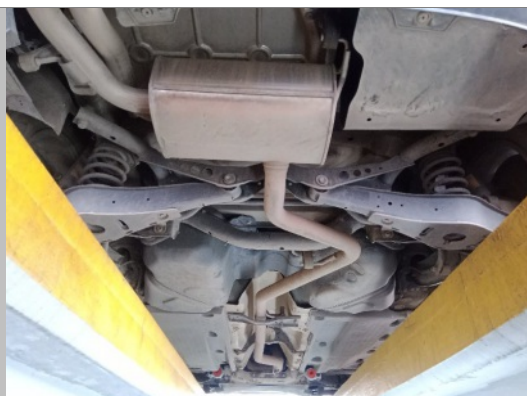
Chassis 2

General Comments: ACCORDING TO THE AGE AND MILEAGE OF THE VEHICLE, NORMAL WEAR AND TEAR MARKS ARE VISIBLE ON THE INTERIOR, EXTERIOR, ELECTRICAL AND MECHANICAL PARTS. Engine Compartment: Engine and gearbox mostly covered underneath.  
Body • Exterior: Minor dents, scratches and stone chips on some body panels. Cosmetical spraywork done to some body panels.  
Undercarriage: Lower gearbox mounting slightly perished.
