## Assignment

## Vehicle Data

| Manufacturer | MERCEDES-BENZ | Registration Number | CY58SZZN |
| Model | CLA 180 [2013-2014] | Register Number | VDP953W |

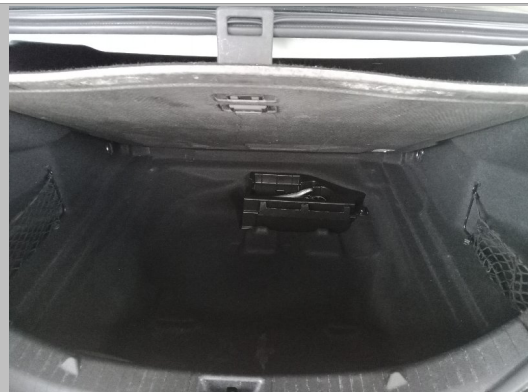
No sparewheel

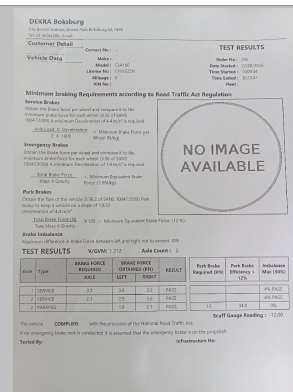
Brake report

| | Left | Right | | |
| | Braking Force [KN] | Braking Force [KN] | Axle Weight [KG] | Deceleration [m/s <sup>2</sup> ] |
| Front | 3.6 | 3.5 | - | |
| Rear | 2.5 | 2.6 | - | |
| Emergency / Parking | 1.9 | 2.1 | - | |

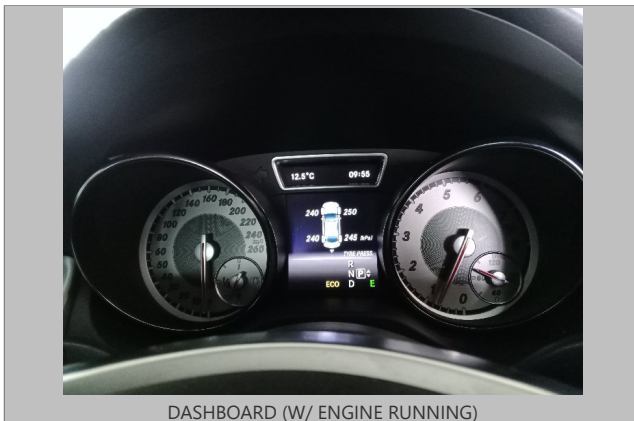
General Comments: ACCORDING TO THE AGE AND MILEAGE OF THE VEHICLE NORMAL WEAR AND TEAR MARKS ON INTERIOR, EXTERIOR, ELECTRICAL AND MECHANICAL PARTS. Engine Compartment: Top right side engine mounting rubber perished and soft. Splash cover wet not dripping. Electrical Components and Instruments: Driver airbag malfunction warning, intermittent illumination. Body • Exterior: Minor dents, scratches and stone chips on some body panels. Cosmetical enhancements done to some body panels. Brakes: Rear brake discs dished. Undercarriage: Engine, transmission and undercarriage mostly covered underneath.

DASHBOARD (W/ ENGINE RUNNING)

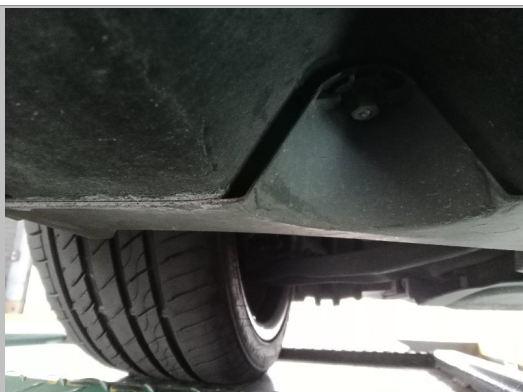
LF TYRE TREAD

| | Size | Load/Speed Index | Manufacture | Model | Type* | Production Date | Tread Depth (mm) |
|---|---|---|---|---|---|---|---|
| Front Left | 225/40R18 | 92W | I Link | L Zeal | V | 1326 | 5 mm |

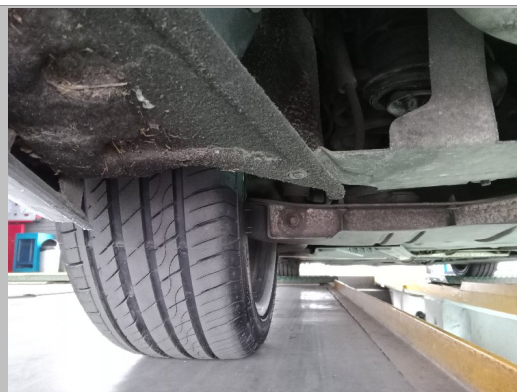
LR TYRE TREAD

| | Size | Load/Speed Index | Manufacture | Model | Type* | Production Date | Tread Depth (mm) |
|---|---|---|---|---|---|---|---|
| Rear Left | 225/40R18 | 92W | I Link | L Zeal | V | 1326 | 5 mm |

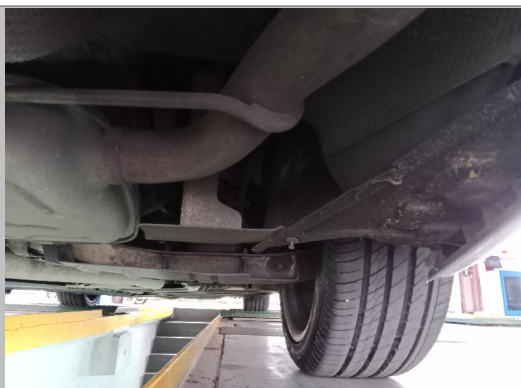
RR TYRE TREAD

| | Size | Load/Speed Index | Manufacture | Model | Type* | Production Date | Tread Depth (mm) |
|---|---|---|---|---|---|---|---|
| Rear Right | 225/40R18 | 92W | I Link | L Zeal | V | 1326 | 5 mm |

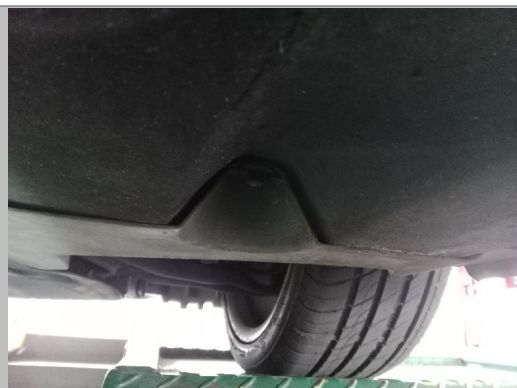
RF TYRE TREAD

| | Size | Load/Speed Index | Manufacture | Model | Type* | Production Date | Tread Depth (mm) |
|---|---|---|---|---|---|---|---|
| Front Right | 225/40R18 | 92W | I Link | L Zeal | V | 1826 | 5 mm |
